Cedar, Pitch & Whitewood Creeks

Benthic Invertebrate and Fish Community Assessment

April 5, 2011

Prepared for:
OMNR Stewardship Program
Thunder Bay District

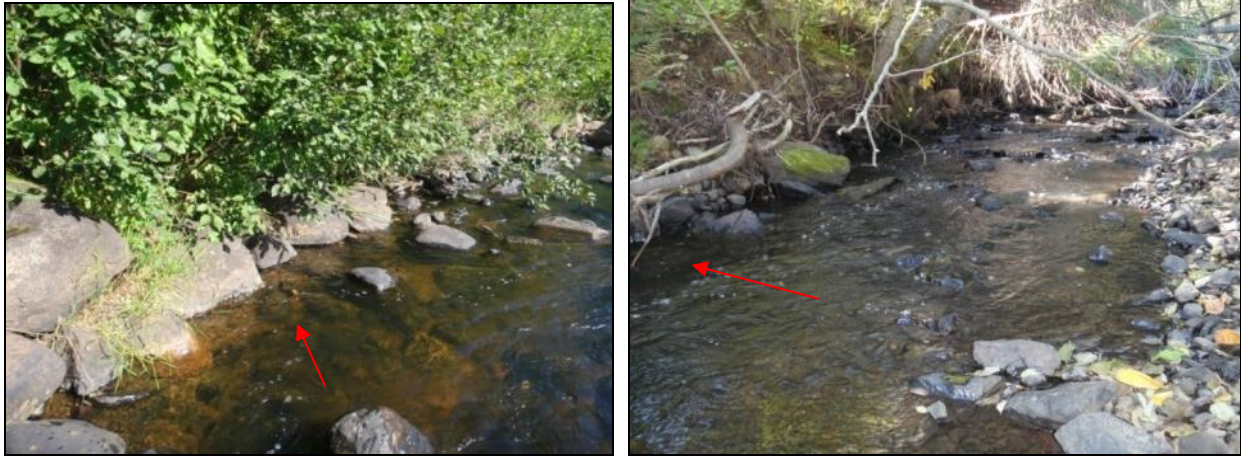
Figure 3. Water temperature logger (arrow) on Cedar Creek at Site 6 (L) and Pitch Creek at Site 19 (R).

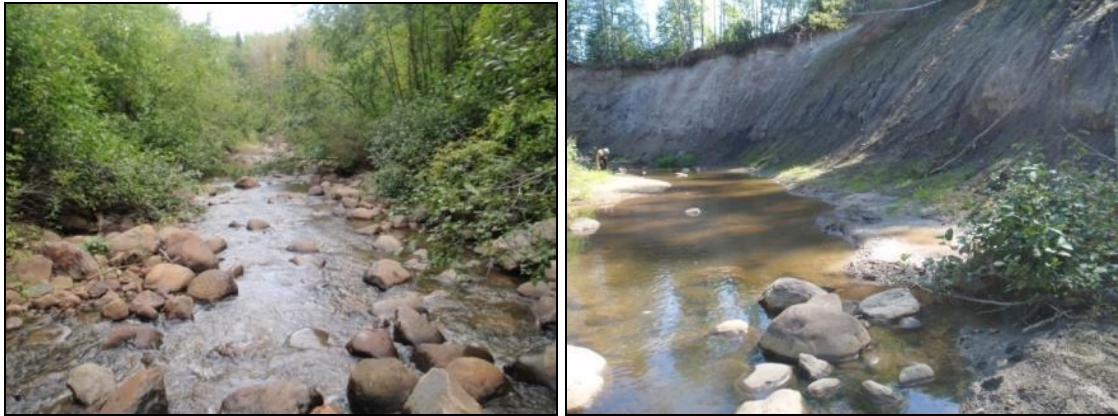
Figure 6. Boulder and cobble riffle at Site 14 on Whitewood Creek (L) and corner pool with steep silty-clay bank at Site 6 on Pitch Creek (R).

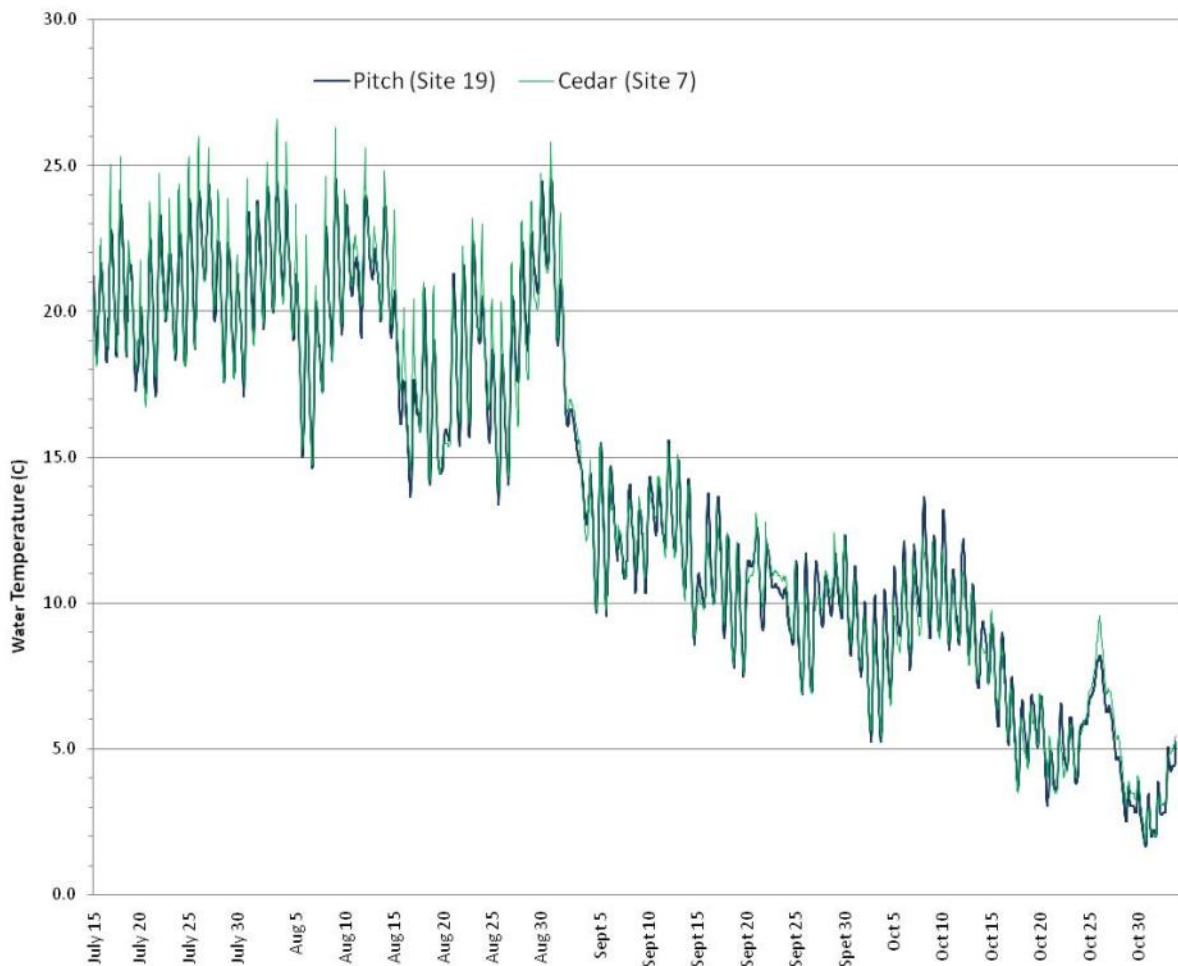
Figure 9. Hourly water temperature at Pitch and Cedar creeks, July 15 to November 1, 2010.

After a relatively warm August with water temperatures well above 15°C in Pitch and Cedar, water temperature dropped dramatically in September in response to cooling air temperatures. Conditions in the Thunder Bay, and likely the study area, were warmer and drier in early 2010 than average. Mean daily air temperature in Thunder Bay Airport (WeatherStats 2011) was 19.7° C in July 2010 vs. 17.6° C for the long-term average, and was 2.4°C warmer than average in August (19.0° C vs. 16.6° C). Precipitation at the Thunder Bay Airport was much lower in spring and summer 2010 than normal, with only 265 mm of precipitation from March through August compared to 412 mm for the long-term average (Environment Canada 2011). Precipitation in the fall was slightly higher than average in 2010 however, and mean air temperatures returned to normal as well in September (10.7° C vs. 11.0° C). As a result, water levels in the streams were generally lower than expected during August sampling.

Picard (1995) found that in 1993 the mean and maximum summer water temperatures in Cedar Creek were 17.3°C and 22° C respectively, with Pitch Creek slightly warmer (mean 18.8° and max of 23°C). Barton et al. (1994) considered streams with maximum summer temperature greater than 22°C as marginal brook trout habitat, although 24°C has been used as the upper limit by others (Meisner 1990). Maximum temperatures on both the Pitch and Cedar creeks

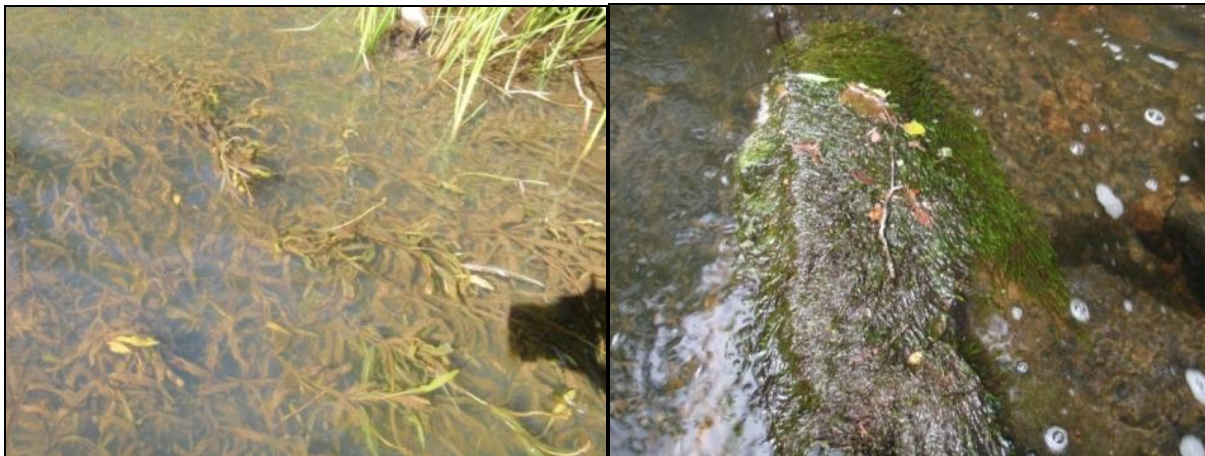
Figure 10. Submergents at Site 12 on Whitewood Creek (L) and aquatic moss on bedrock (L) at Site 4 on Pitch Creek.

The aquatic moss, *Fontinalis novae-angliae* was abundant at several sites (e.g., Site 3,4,7) (Figure 10). Higher algae abundance was observed in pools downstream of water crossings, due to increased sunlight along the road corridor, and potential input of nutrients from roadside ditches. Effects appear to be minor and local however. Crustose algae was also abundant at Site 6 on Cedar Creek, and filamentous algae was also abundant at Site 5 where the cascading steps have a southern exposure promoting growth (Figure 11).

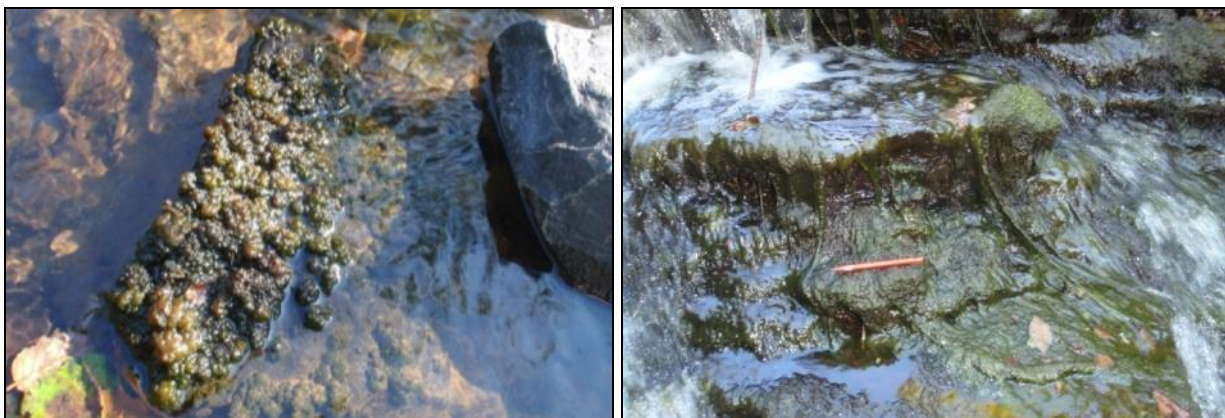
Figure 11. Algae on cobble at Site 6 on Cedar Creek and (L) filamentous algae at Site 5 on Pitch Creek (R; mechanical pencil for scale).

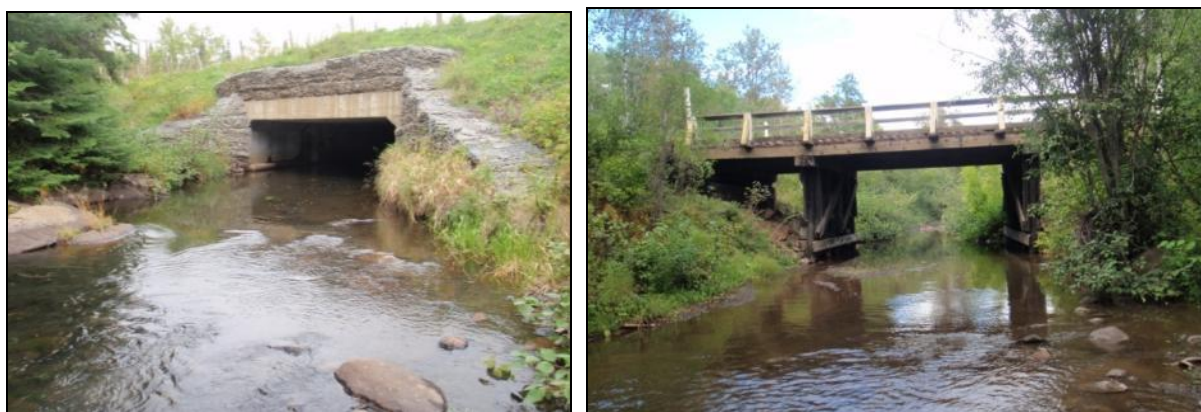
Figure 13. Box culvert on Cedar Cr. at Hwy 590 (L) and bridge over Whitewood Cr. at Smith Road (R).

All three tributaries cross numerous roads from their headwaters to their confluence with the Whitefish River, but most are bridges or box culverts that have natural bottoms (Figure 13). The large-diameter culverts on these tributaries probably do not pose a barrier to upstream movement to fish, although they could potentially represent a velocity barrier for some species at high flows. Numerous beaver dams may hinder upstream and downstream passage of fish, but are natural features of these watersheds. Sea Lamprey Control Centre personnel routinely break up numerous beaver dams on Pitch Creek when conducting lampricide treatments every 3-4 four years to increase flow and reduce the wetted area during treatment.

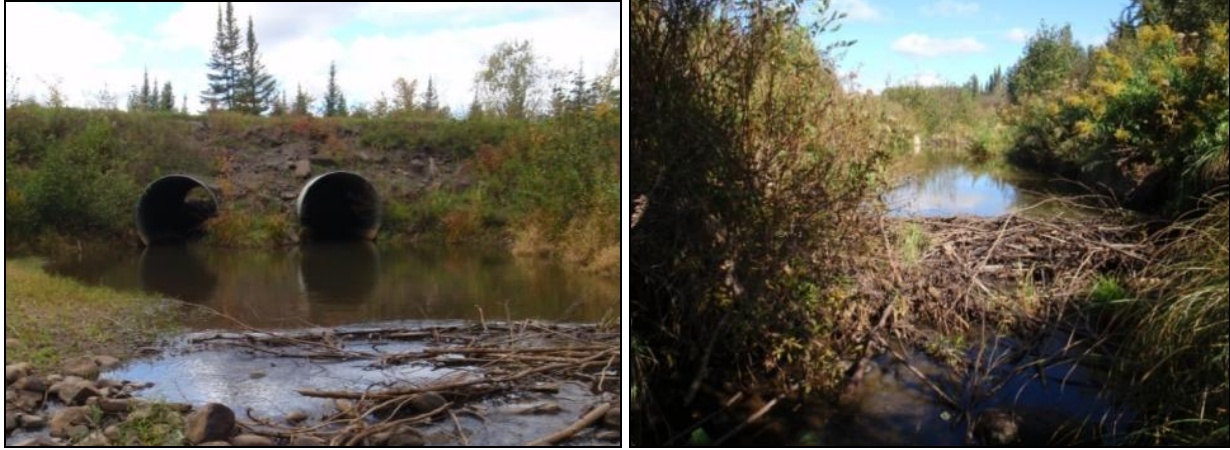
Figure 14 double culvert on Whitewood Creek at Hwy 590 (L) and Beaver dam on Rock Run Creek above Site 18 (R).

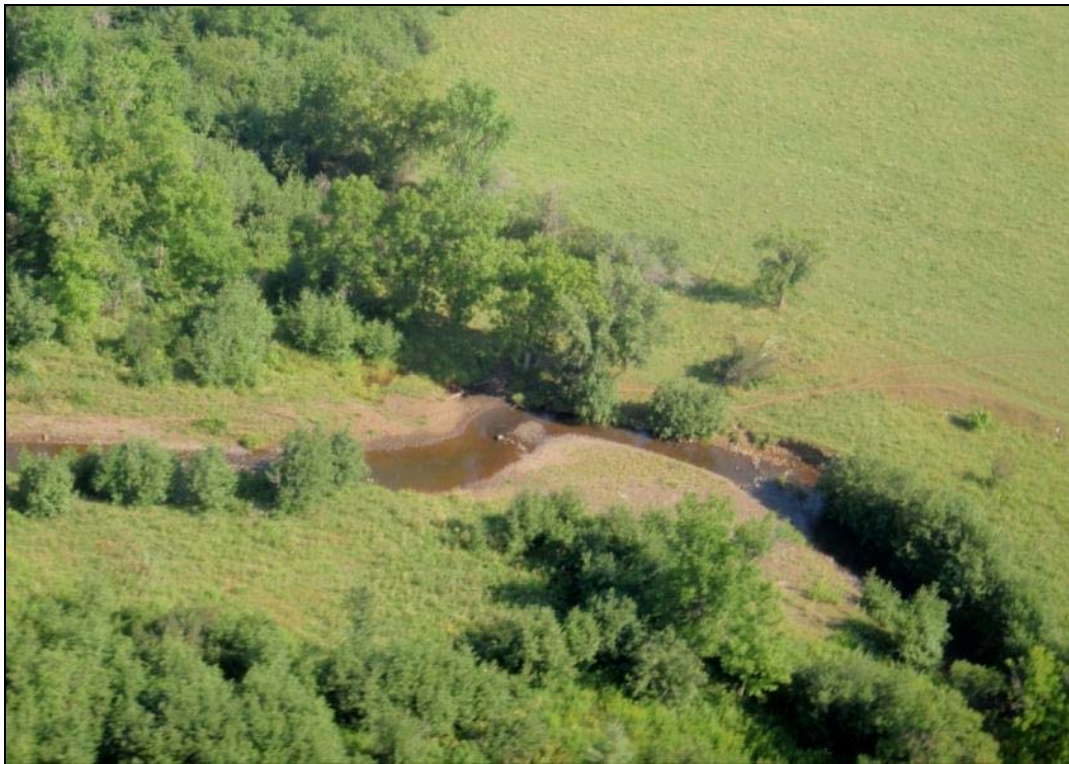
Figure 25. Cattle trail and adjacent pasture at Site 9 on the lower reaches of Cedar Creek.

Some erosion is a natural process as creeks cut through soft deposits, and there are other locations (e.g., Site 9) on the lower Pitch Creek with slumping silty clay banks similar to Site 6. These glaciolacustrine deposits are particularly susceptible to erosion which can be accelerated from improper land use practices, leading to siltation in Cedar Creek and farther downstream i.e., Whitefish River, Kaministiquia River. Siltation can have negative impacts on aquatic biota such as suffocating fish eggs (Kerr 1995), and may contribute to the lower fish biomass at Site 6. However, it is difficult to separate out direct or indirect farming-related impacts from natural habitat variability associated with landscape position. In particular, the streams become wider, shallower, slower, and more soft-bottomed on glaciolacustrine delta deposits in their lower reaches compared to on tills higher in the watershed.

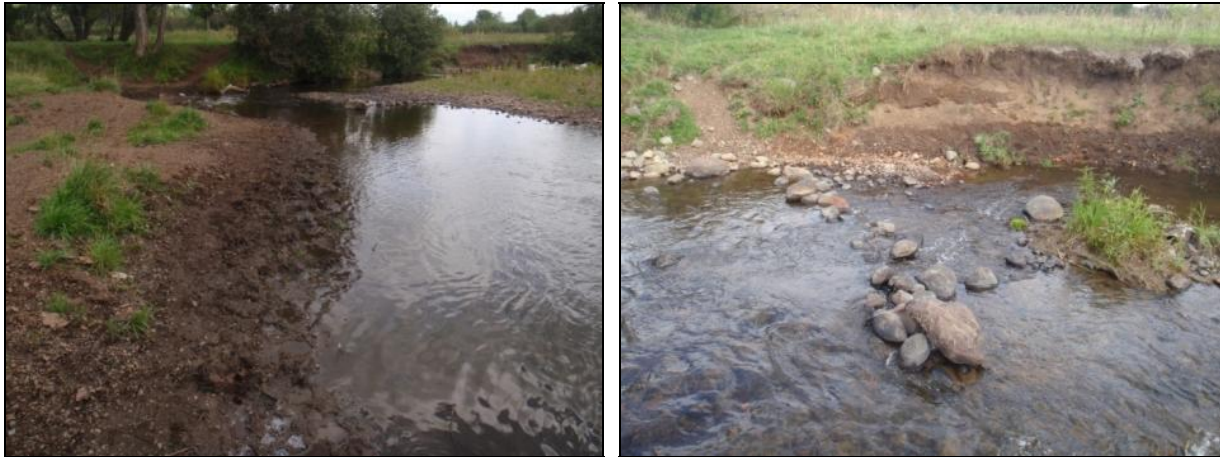
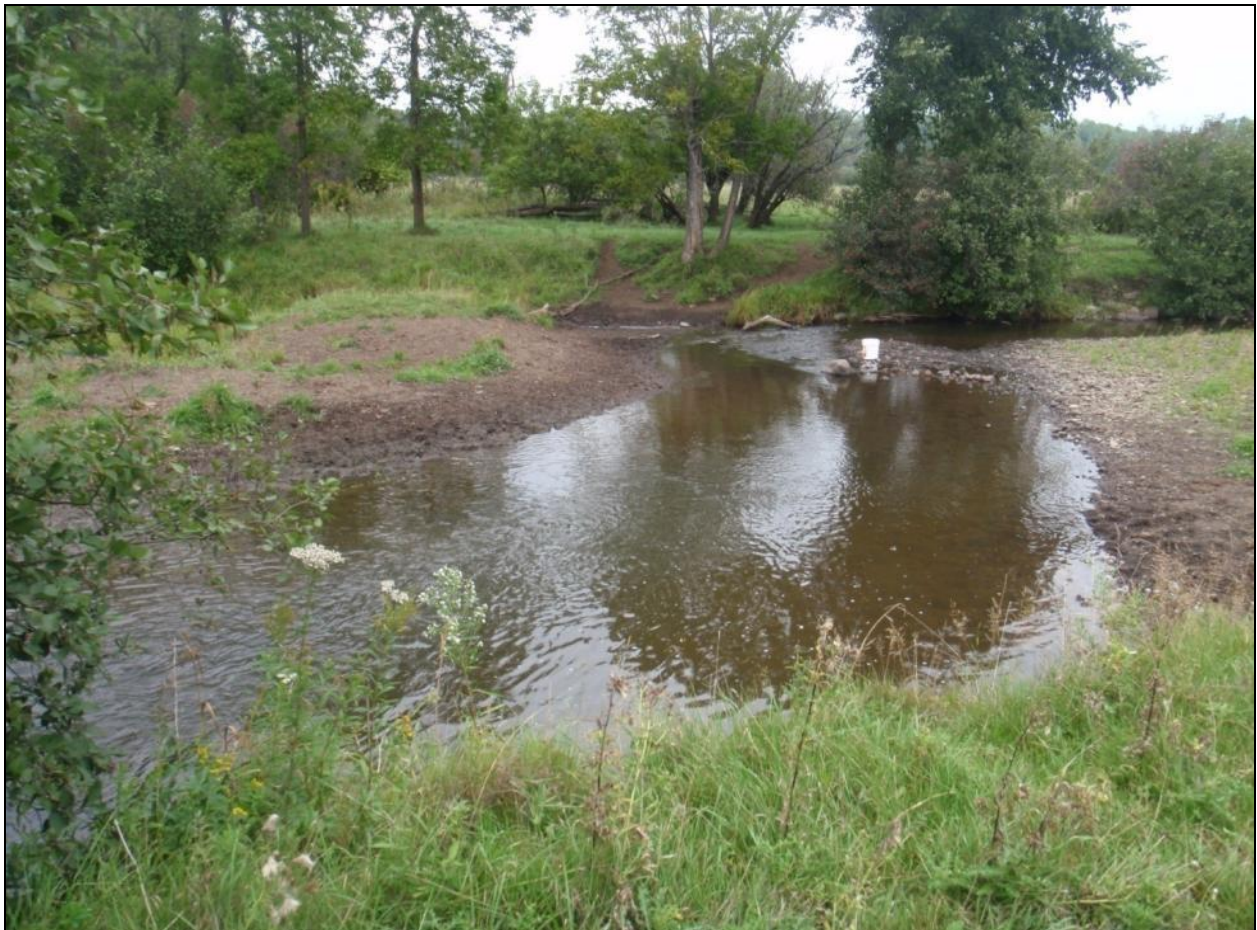
Figure 26. Lower reach of Cedar Creek with cow paths, streamside trampling, and eroding bank.

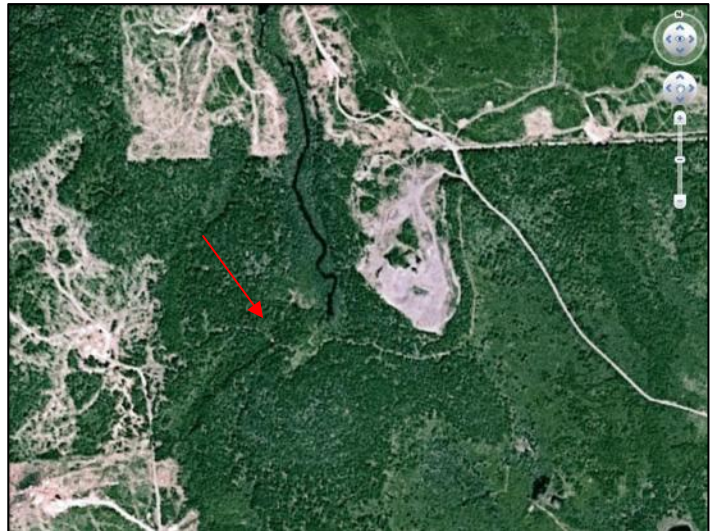
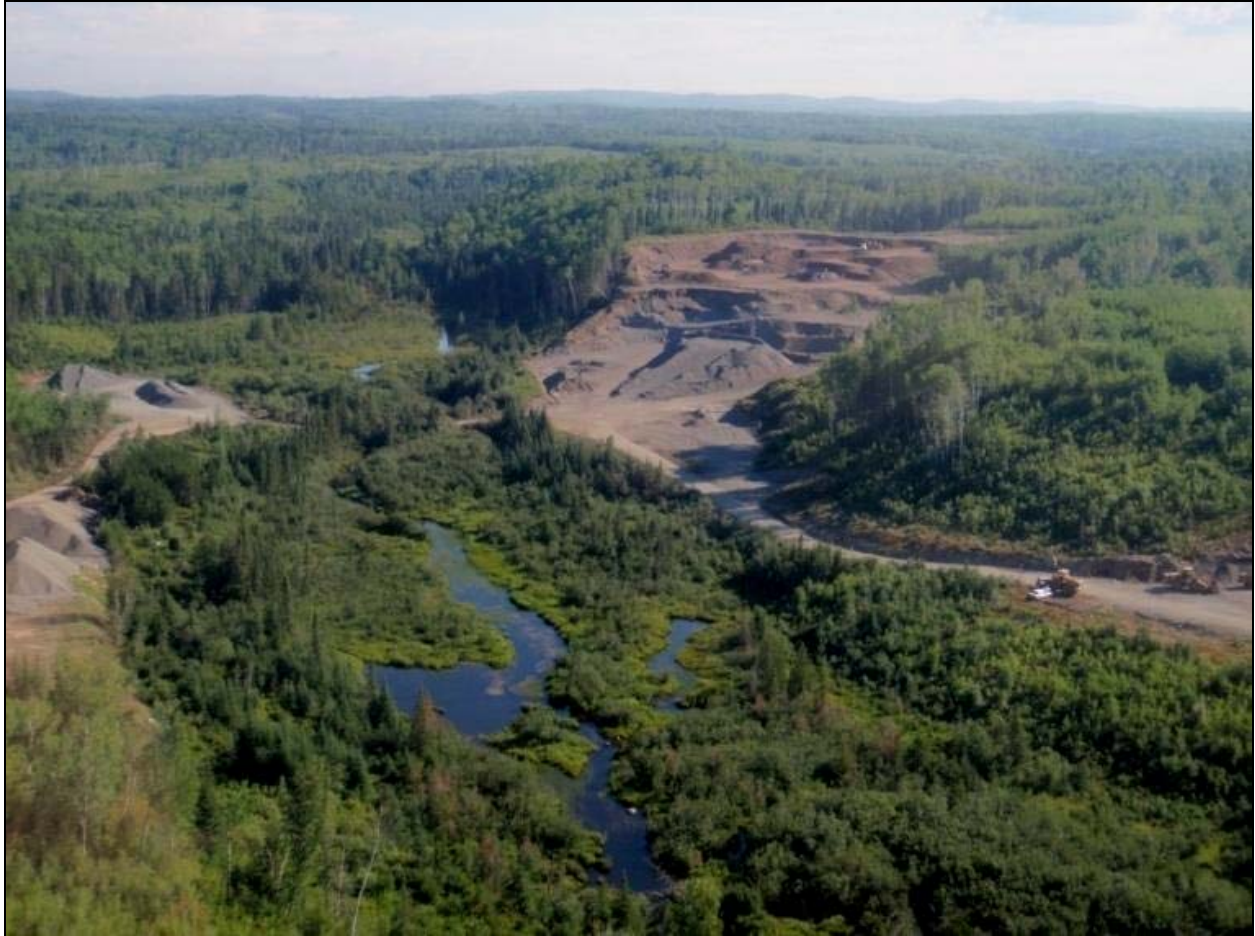
Figure 27. Gravel pit near Cedar Creek (lower) and in relation to Site 8 (red arrow; upper right).

A large (approximately 14 ha) gravel pit is located approximately 300 m northeast of Site 3 and adjacent to Cedar Creek (Figure 27) on a coarse glaciofluvial deposit. There are several other smaller aggregate pits associated with forest access roads in the western part of the study area. Although there was only a narrow riparian buffer adjacent to the gravel pit, no apparent effects of the gravel pit (e.g., siltation) were detected downstream at Site 3. Brook trout and sculpin were abundant at this site indicating no impairment of water quality.

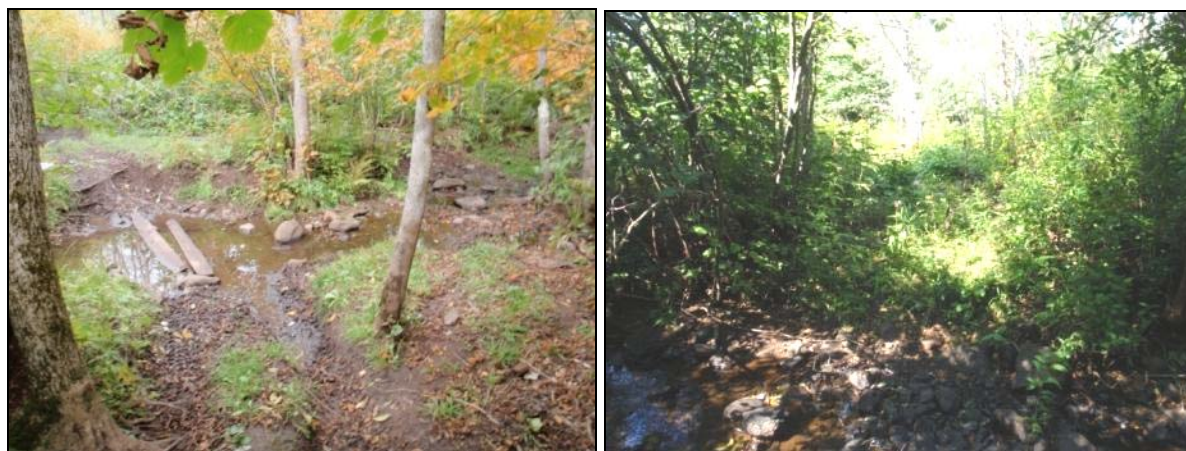
Figure 28. Quad trails crossing stream at Site 15 (L) and Site 8 (R).

Trails created by all terrain vehicles (ATV) and informal footpaths, likely from anglers, were observed at several sites on private land (Sites 8, 15, 18, 20). In contrast, the snowmachine trail that crosses Cedar Creek at Site 8 on Crown land has a proper bridge structure. On an unnamed tributary of Whitewood Creek at Site 15, an ATV trail crosses at two locations (Figure 28). Boards have been placed to facilitate crossing and other boards have washed downstream into the next pool. There is erosion of silty-clay banks and siltation in the pool downstream. However, the impacts are localized to the first pool downstream, and pools farther downstream do not appear to be negatively impacted. Erosion at Site 8 on Rock Run Creek is extensive and has led to the development of multiple crossing points (Figure 29). Although there are fairly significant local impacts, they are less extensive or profound than the habitat changes associated with the beaver dam and pond immediately upstream. In contrast, there are minimal impacts to the watercourse at Site 8 where an ATV trail crosses the cobble bottom (Figure 28).

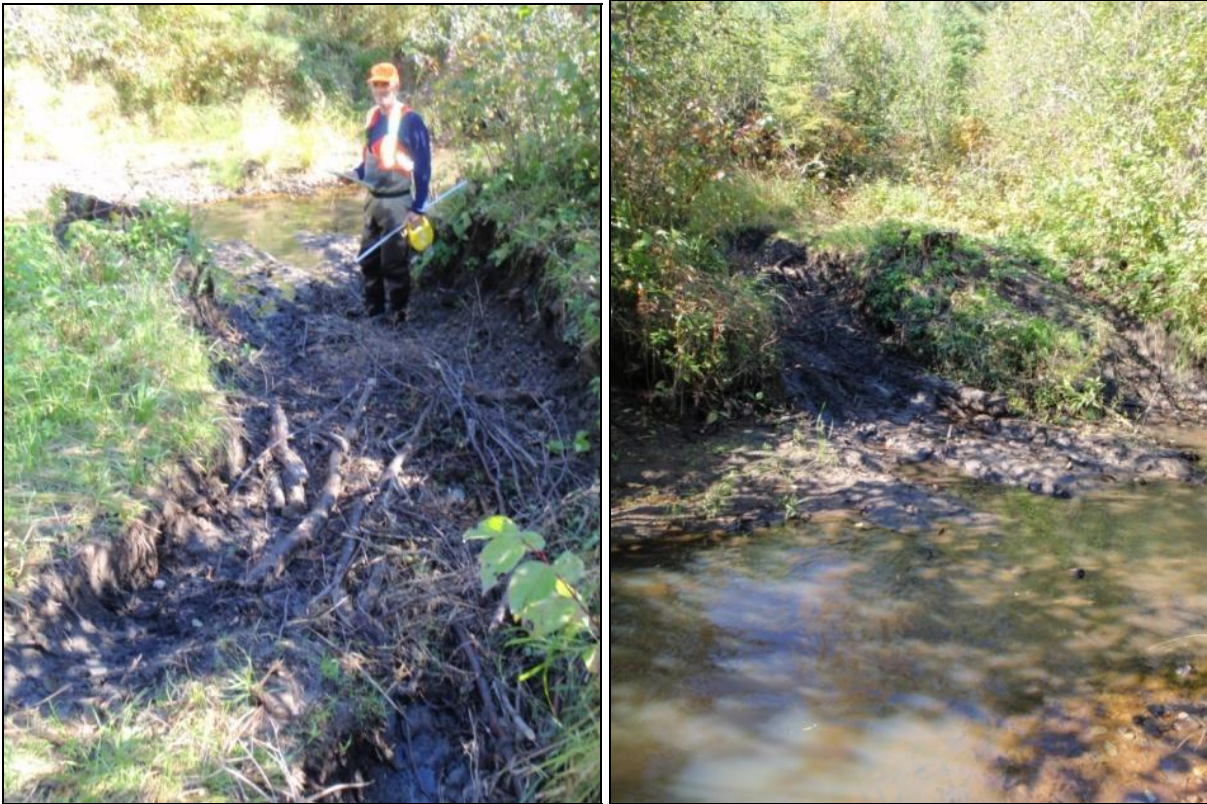
Figure 29. Quad trail through Rock Run Creek at Site 18 and resulting streambank erosion.

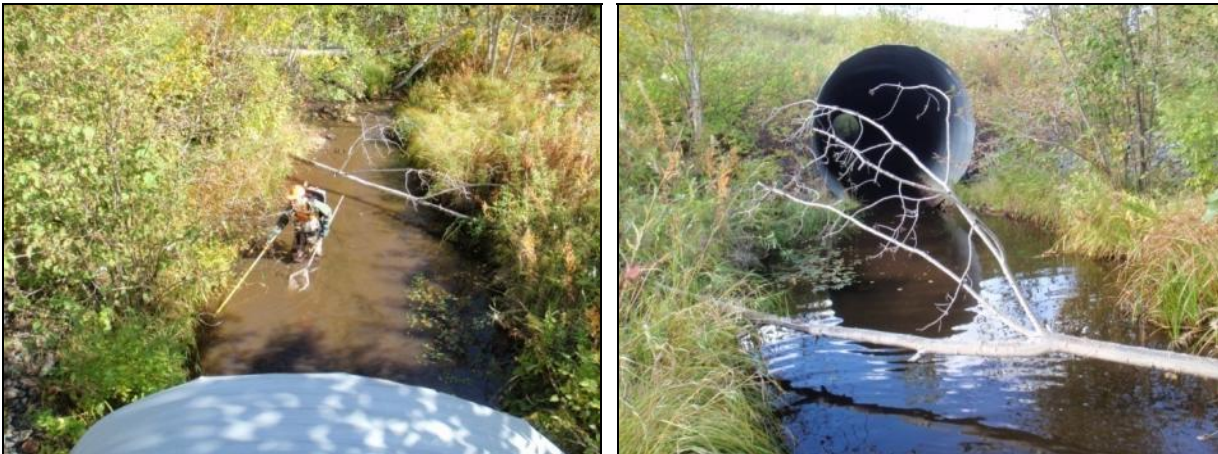
Figure 30. Muddy culvert pool below Site 17 on Whitewood River.

Roadways can create pools by creating impoundments on the upstream end of improperly sized culverts, or when they are shallowly installed such as at Site 1 on Cedar Creek (see Appendix 4, Site 1). Scour pools can also develop on the downstream side of culverts such as at Site 25 on the Whitewood River (Figure 30) and above Site 20 (Figure 14). At Site 25, the silt-bottomed pool was approximately 8 m x 6 m with a maximum depth of 65 cm (mean 50 cm) with an associated small patch of pondweeds (*Potamogeton* sp.). The pool provides habitat for a relatively large number of good-sized brook trout; a total of 25 brook trout with a mean TL of 154 mm were sampled there in 235 seconds of electrofishing. A conversation with the adjacent landowner indicated that brook trout have traditionally been angled from this pool. The

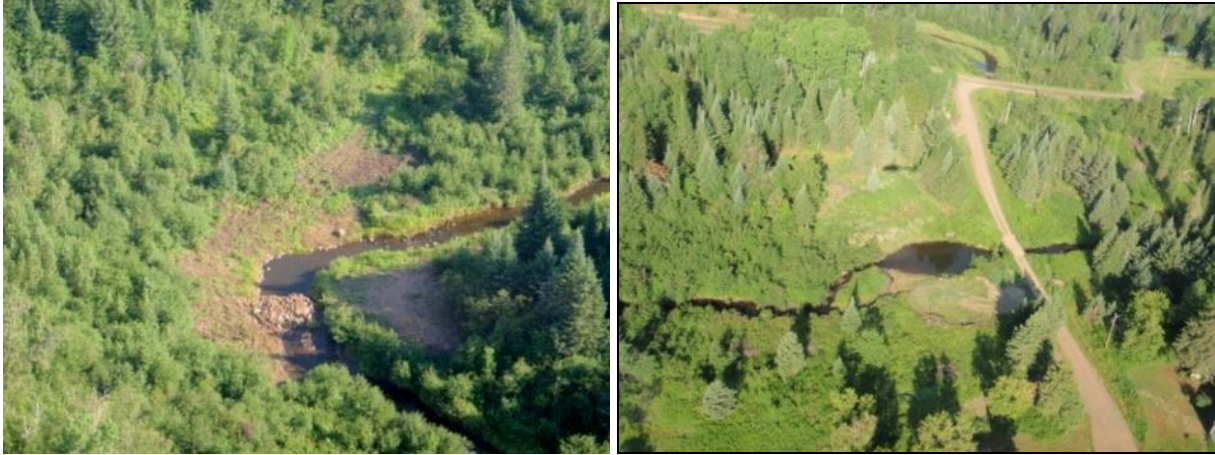
Figure 31. Unauthorized earthen barrier on stream (L) and apparent man-made pool below water crossing on private road (R).

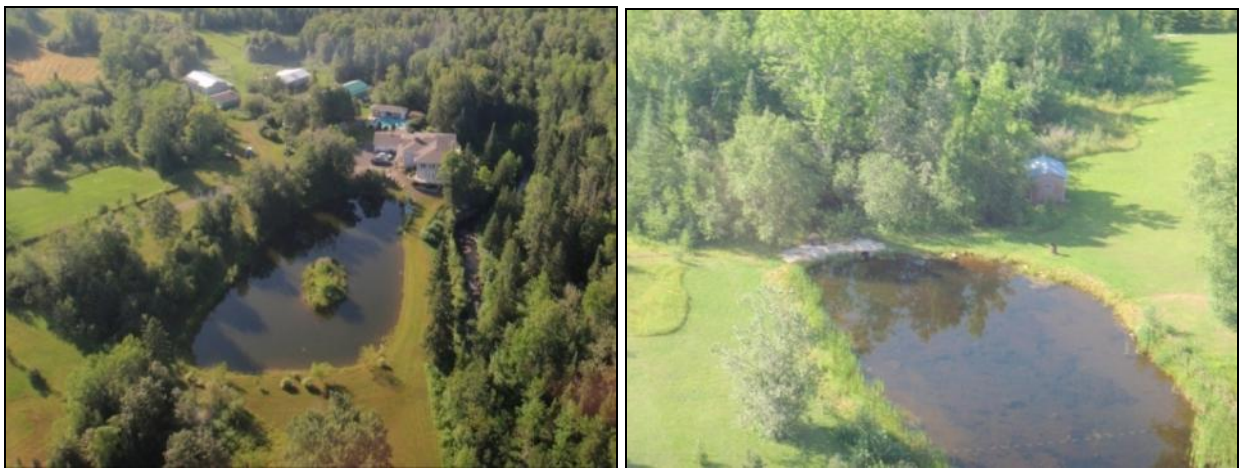
Figure 32. Man-made pond adjacent to Cedar Creek (L) and on upper reaches of Pitch Creek (R).

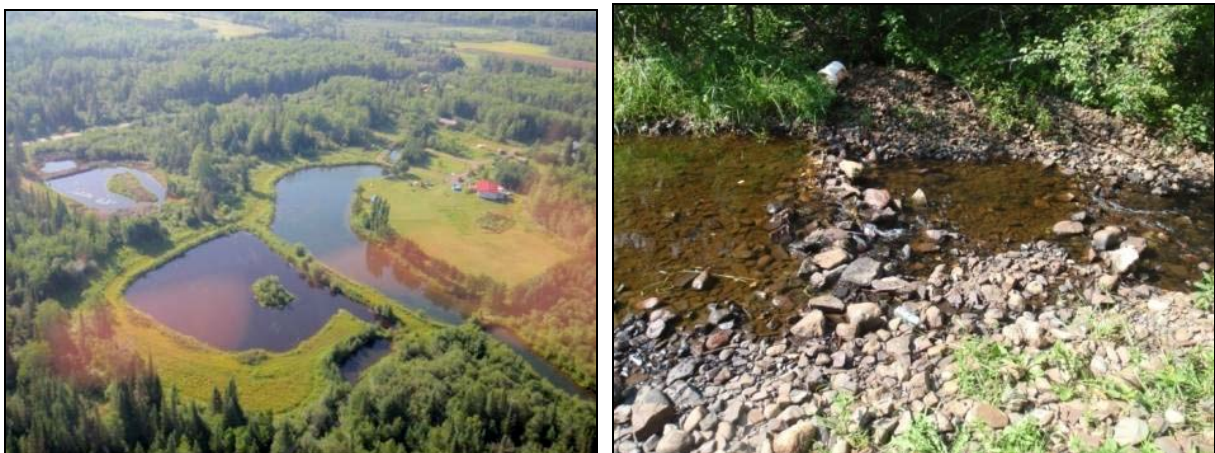
Figure 33. Rainbow trout rearing ponds near Rock Run Creek (R) and small check dam at outlet of culvert pool at Site 8 on Whitewood Creek.

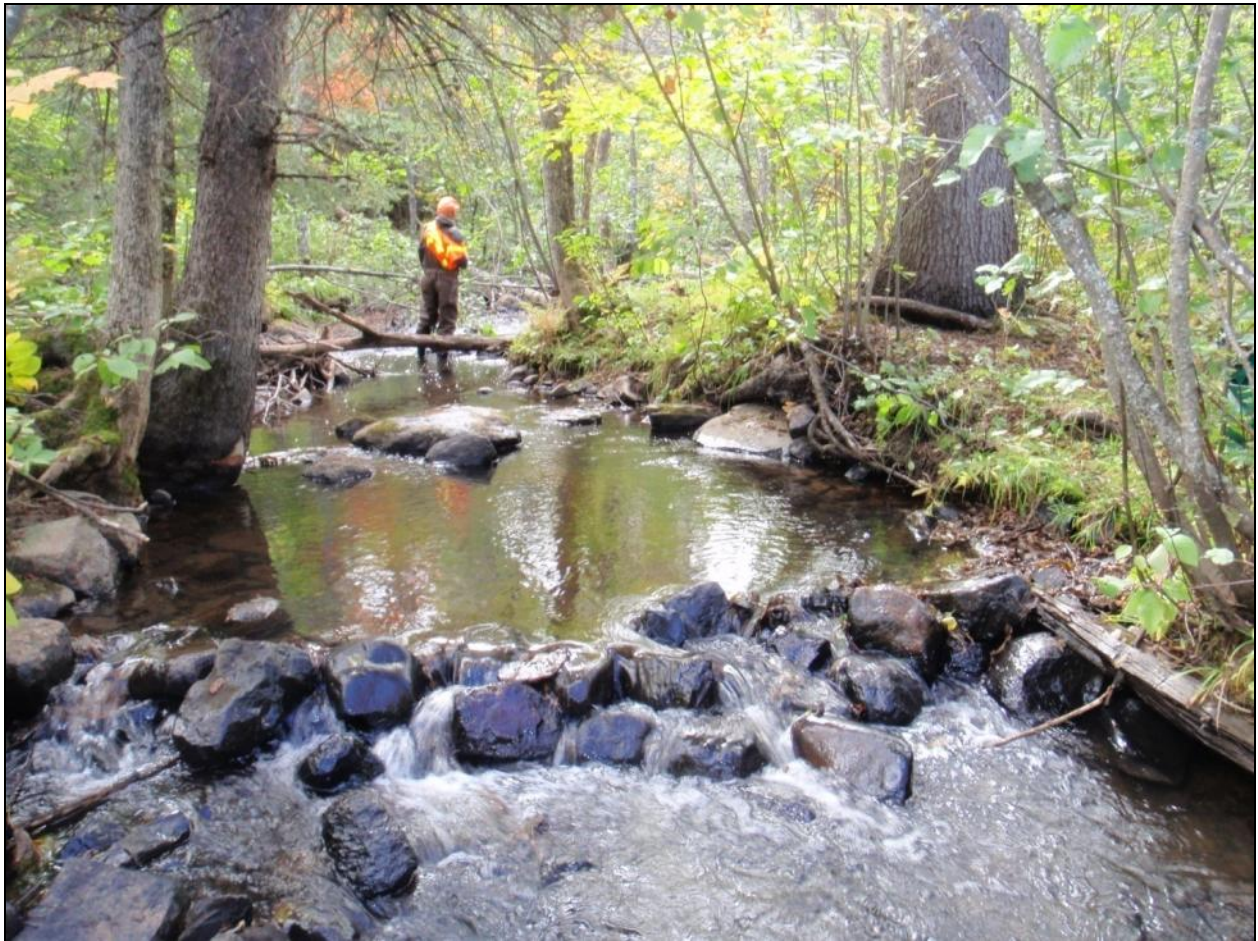
Figure 34. Rock dam at Site 16 on Whitewood Creek.

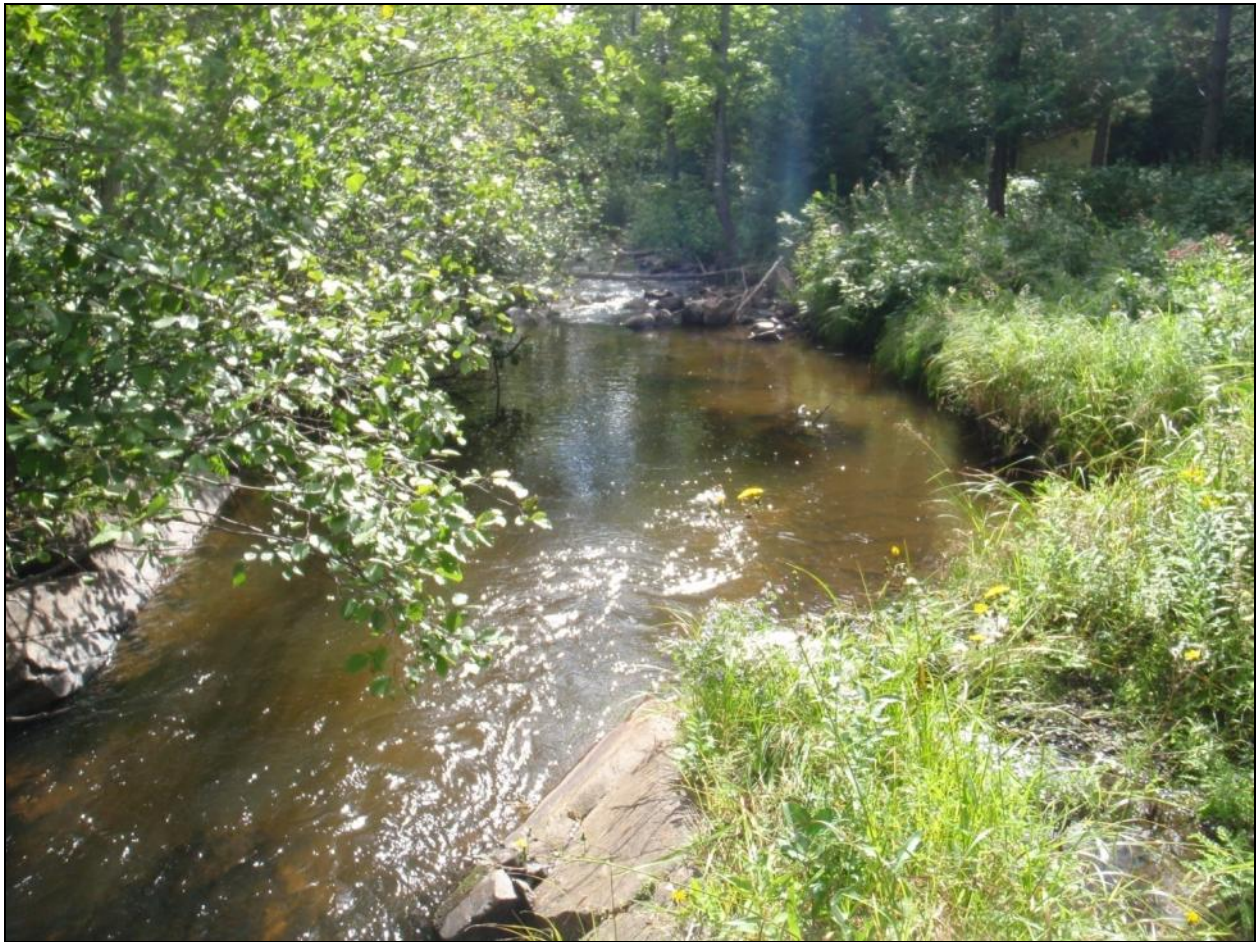
Figure 36. Modified pool at Site 2.

In at least two instances, coarse woody debris appears to have been removed from the modified pool presumably to facilitate swimming/bathing or to reduce snags when angling. Trees and other riparian vegetation have been partially or entirely removed adjacent to a number of these pools or residences (Figure 32, Figure 32, Figure 35) presumably for aesthetics, to increase sunlight, or to reduce biting insects. Nonetheless, the modified pool at Site 2 (Figure 36), held the largest brook trout observed during the 2010 study (291 mm TL, 293 g).
