2011 Current River Fish Habitat Assessment

December 1, 2011

Prepared for:
Thunder Bay District Stewardship Council &
Ontario Ministry of Natural Resources
Thunder Bay, ON

Prepared by:
Dr. Robert F. Foster

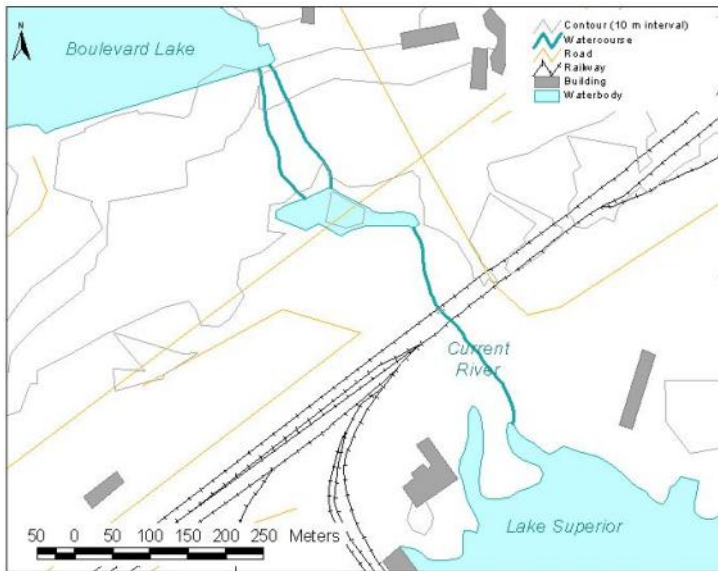
Figure 1. Existing OMNR NRIVS mapping for Current River mouth.

OMNR base mapping layers for the Current River mouth available from Ontario Ministry of Natural Resources (OMNR) are currently inadequate for fish habitat assessment due to extremely coarse scale (Figure 1). Detailed habitat mapping is considered a first step towards addressing fish habitat issues raised previously and movement towards recovery of Thunder Bay walleye populations. In addition, although there has been some fisheries assessment at the mouth of the Current River but no recent work in the river above the islands at the mouth (e.g. ,Geiling et al. 1996; Ball and Tost 1990). The purpose of the current study was to provide a current assessment of the fish habitat and community in the Current River to support future water management planning.

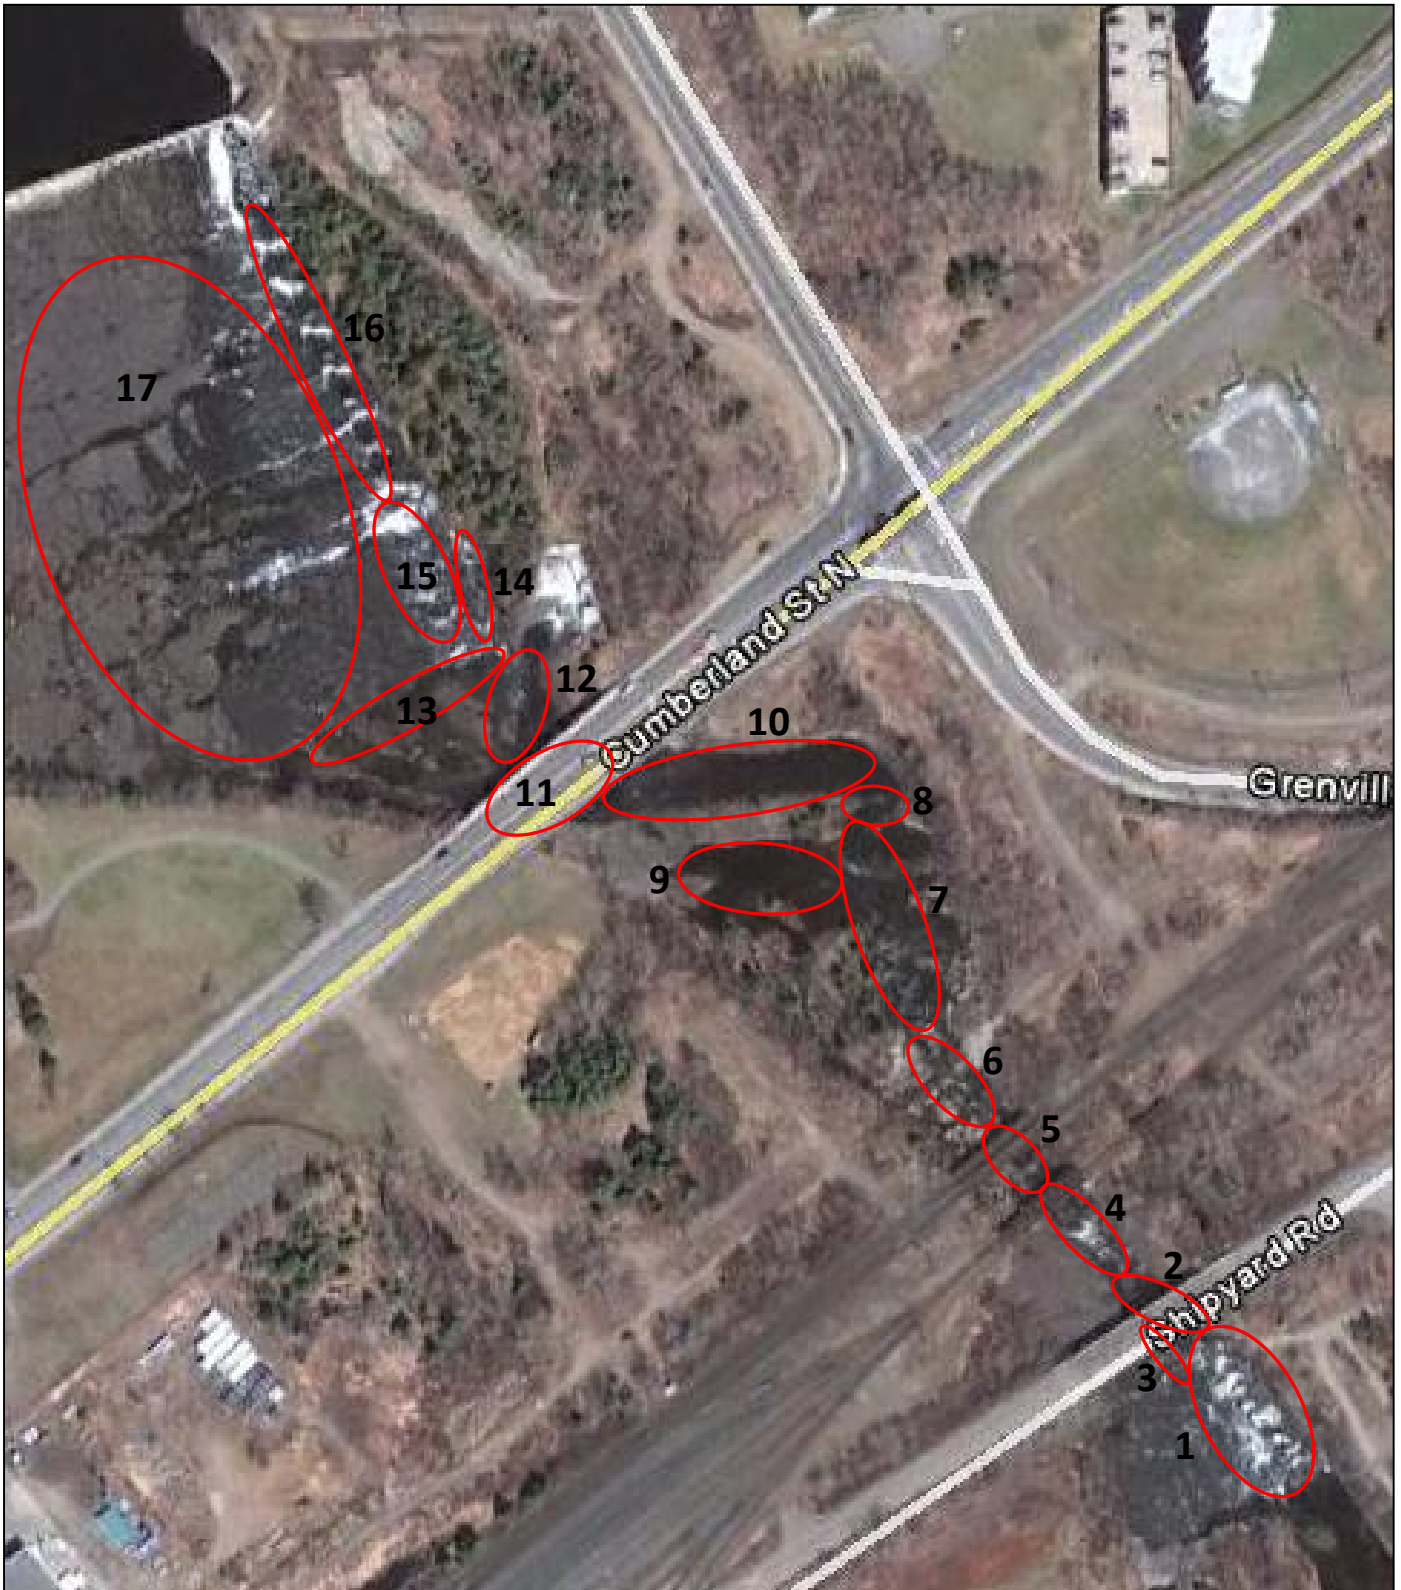
Figure 2. Electrofishing reaches on the Current River below Boulevard Lake, August 31 and September, 2011.

Fieldwork was conducted on August 31 and Sept 27 by Rob Foster (RF), Julian Holenstein (JH), and Brian Ratcliff (BR), and Adam Foster (AF)(Table 1). Fieldwork focused on the Current River below the Boulevard Lake dam to the island at its mouth on Lake Superior (Figure 2).

Table 4. Summary of electrofishing catch from the Current River, Sept 2011. See Figure 2 for location of reaches.

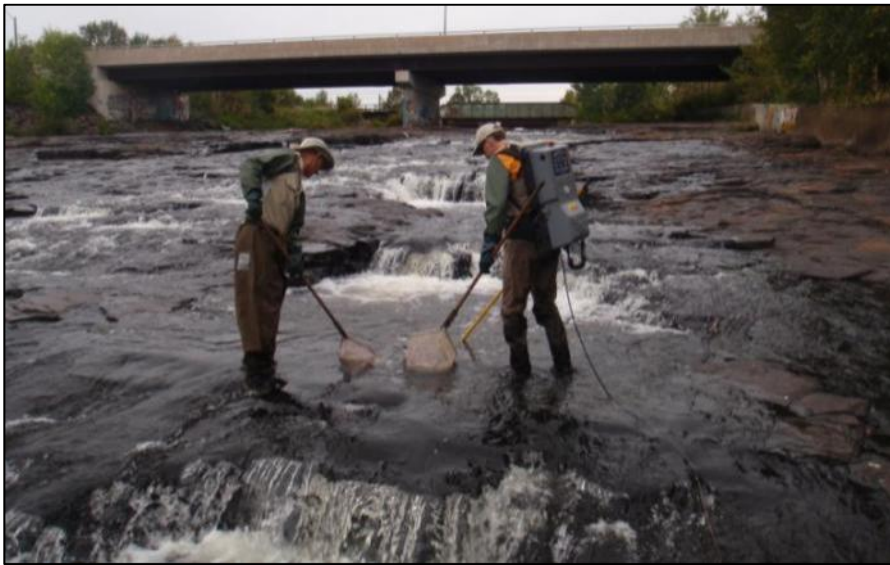
Figure 3. Electrofishing below Shipyard Road bridge on August 31, 2011.

Electrofishing was conducted by a 2- or 3-person crew using a Smith-Root LR-24 backpack electrofisher (Figure 3). Electrofishing generally followed procedures outlined in OMNR (2002) and Stanfield (2005). Single-pass electrofishing was conducted in an upstream direction; barrier nets were not used as low flow conditions effectively created barriers to upstream passage allowing pools or short reaches to be sampled fairly discretely. The Quick Setup function on the LR-24 was used to determine initial electrofisher settings: this function selects a voltage level necessary to achieve 25 watts average power output through the water between electrodes. Typical initial settings were 25% duty cycle, 4.2 m/s pulse width, 400 V and 60Hz. Voltage settings and frequency settings were adjusted as necessary) to achieve levels necessary for fish capture. Work was carried out under Licence to Collect Fish for Scientific Purposes #1064504 issued by Thunder Bay District OMNR. Water temperature was 21° C during sampling.

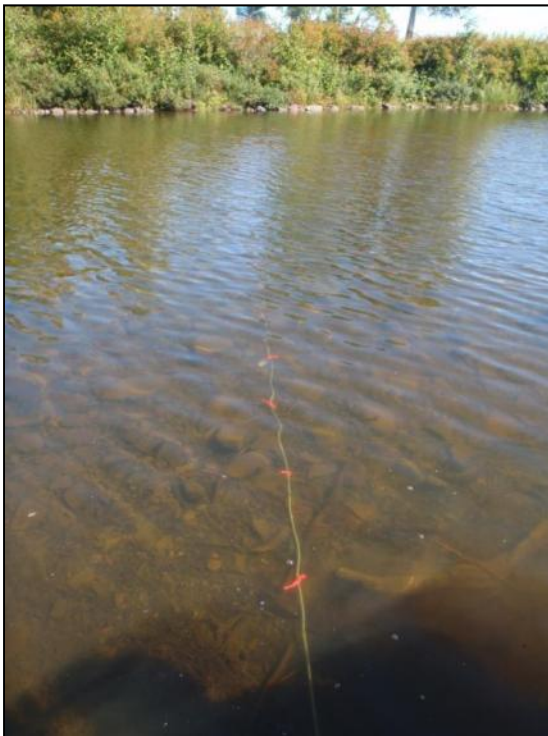
Figure 4. Transect #1 with lead line marked with 50 cm intervals, September 9 2011.

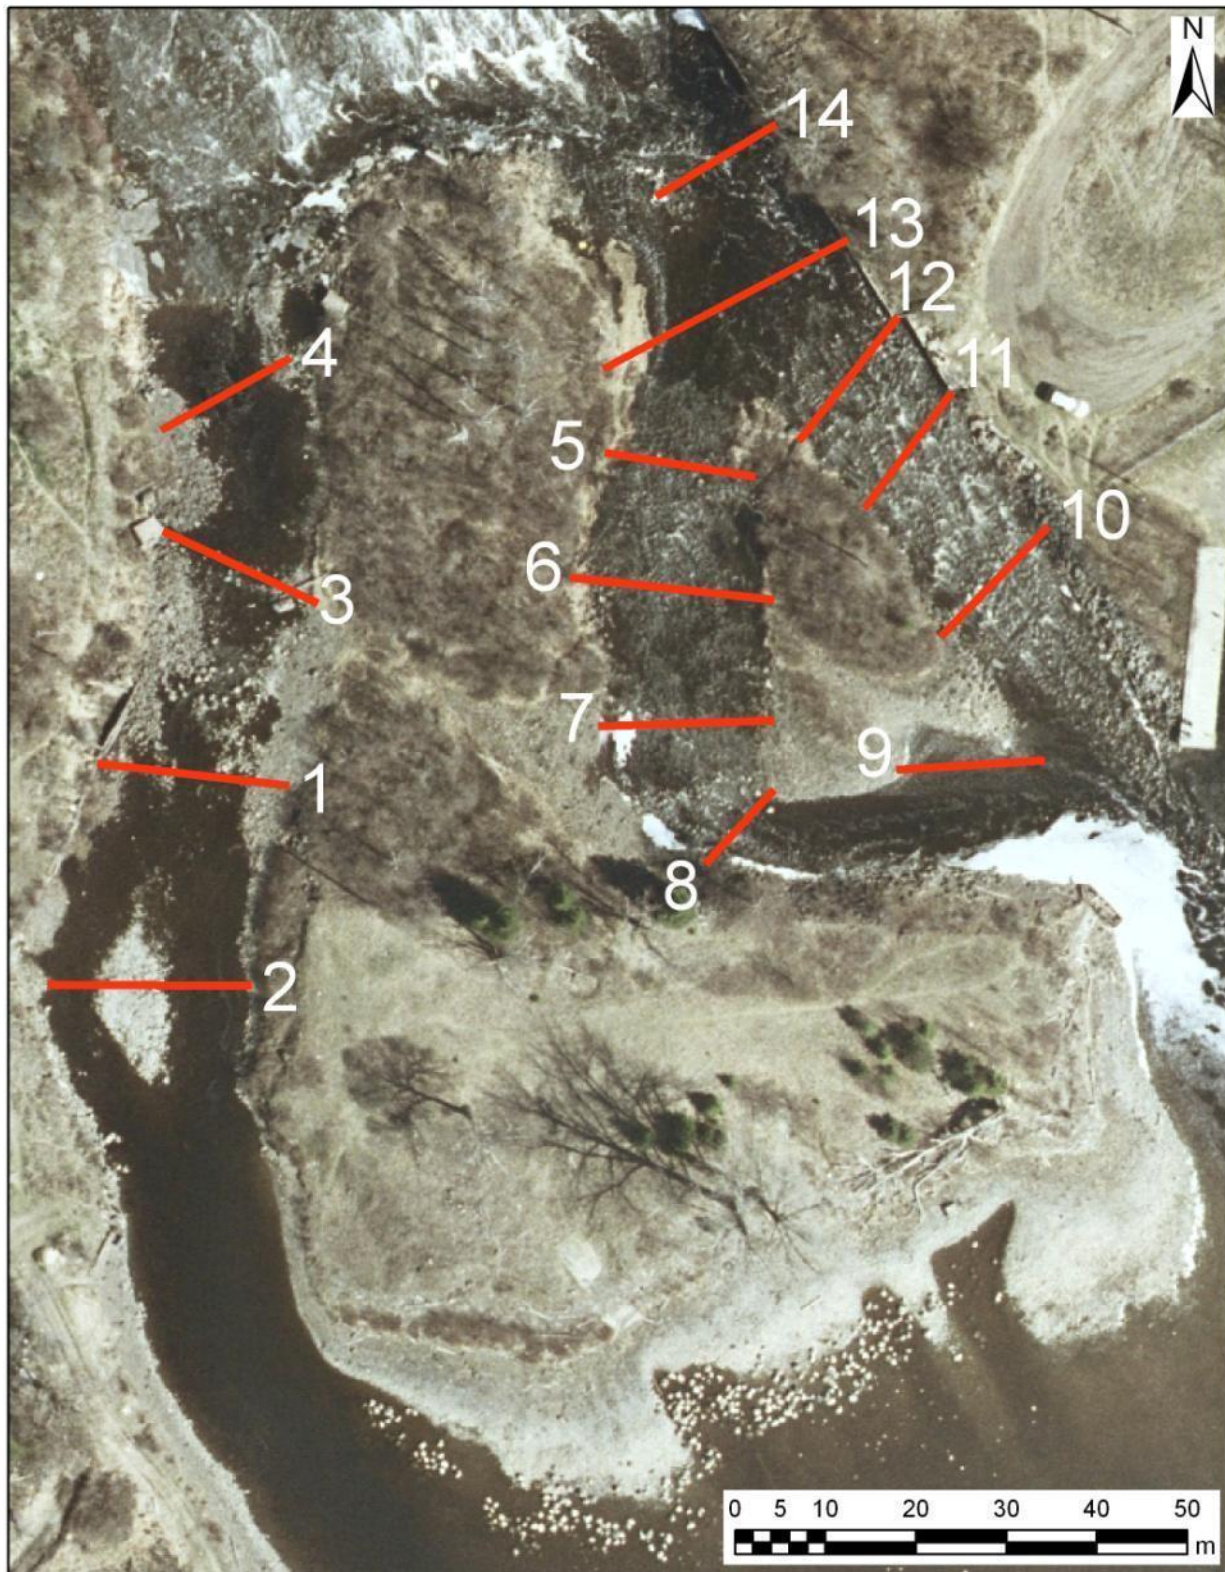
Figure 5. Location of substrate transects at the mouth of the Current River, September 2011. Note: City of Thunder Bay imagery date unknown (actual water levels were lower during sampling).

transect locations (Figure 5) were selected to be representative of habitat conditions at the mouth of the river and also encompass walleye spawning areas identified in Geiling et al. (2006). Transects were established from the high water mark, and each transect was generally oriented perpendicular to the riverbank, with the transect start and end points marked with spraypaint. A lead rope marked with 50 cm intervals was stretched between the endpoints transect. At each 50 cm interval, a 30 cm diameter ring was placed on the river bottom. The particle (e.g., gravel, cobble, etc) at the centre of the ring was selected and the width of its b-axis measured to the nearest mm. The largest particle in the ring was then selected and its b-axis measured as well. Any gravel in the ring (if not the centre or largest particle) was also noted. The degree of fine sediment on the particles was estimated using the following classes: 0-5%, 6-25%, 26-50%, 51-75%, >75%. Water depth (mm) was also recorded.

Appendix 2. Substrate transect data at the mouth of the Current River, September 2011. See Figure 5 for location of transects.

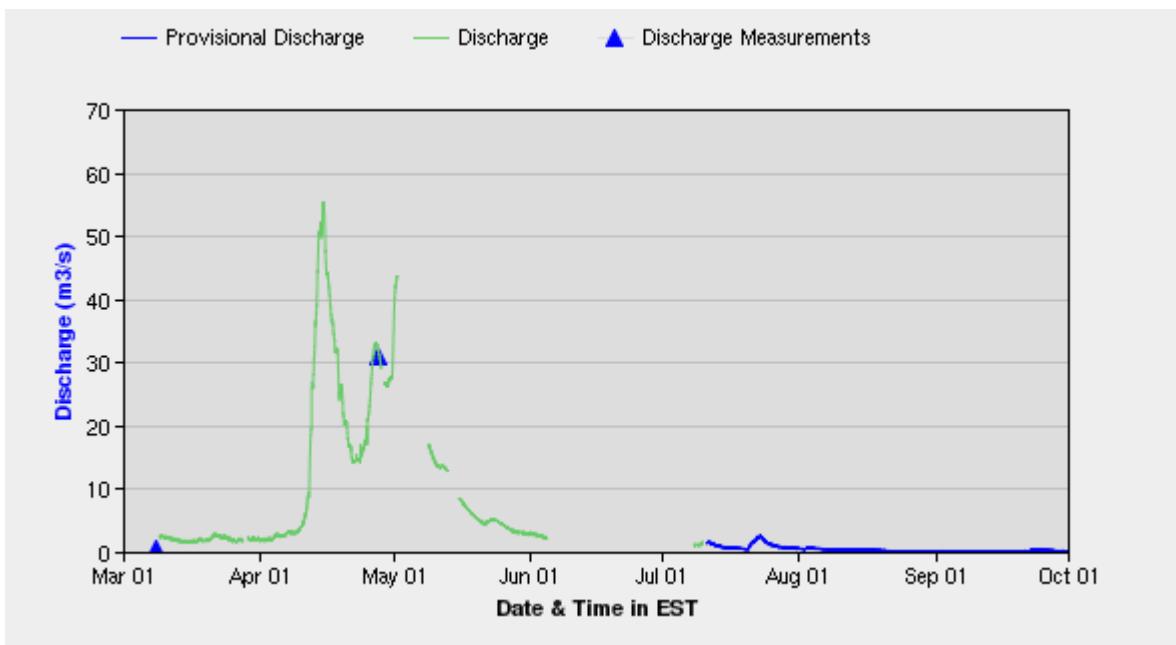
Figure 6. March-October 2011 discharge at Stepstone on the Current River (Environment Canada 2011), approximately 20 km upstream of the study area.

Aquatic habitats on the Current River between Boulevard Lake dam and its mouth at Lake Superior are primarily high energy lentic environments depending of discharge. The nature and extent of the fish habitat are highly dependent upon flows through the Boulevard Lake dam, which in turn are a function of precipitation in the watershed and the water management regime. During 2011 sampling, flows in the study area were almost entirely from leakage through the stop logs at the dam, with very little flow going over the dam and none through the fish ladder (Figure 2). There was below normal precipitation throughout much of the summer and therefore reduced flows at the time of sampling (Figure 6).

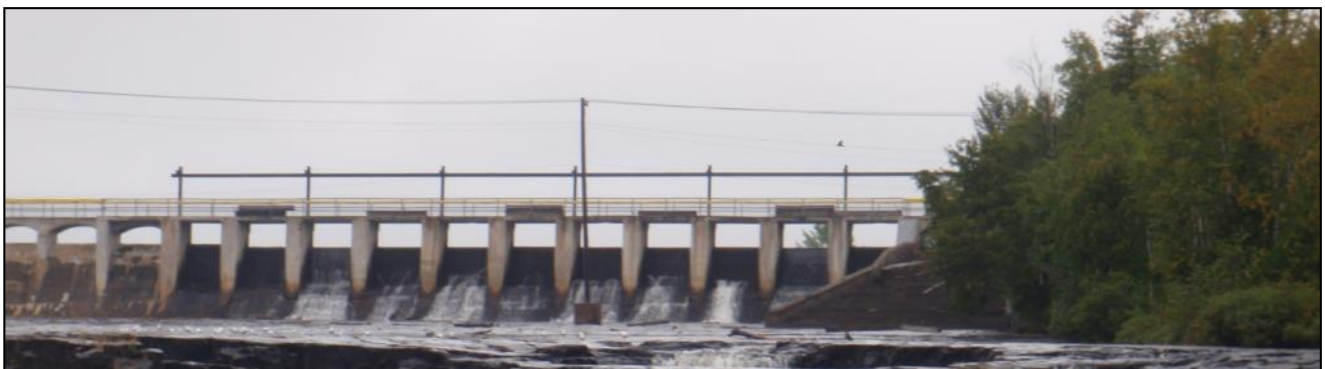
Figure 7. Leakage flows through the Boulevard Lake dam on August 31, 2011 during electrofishing.

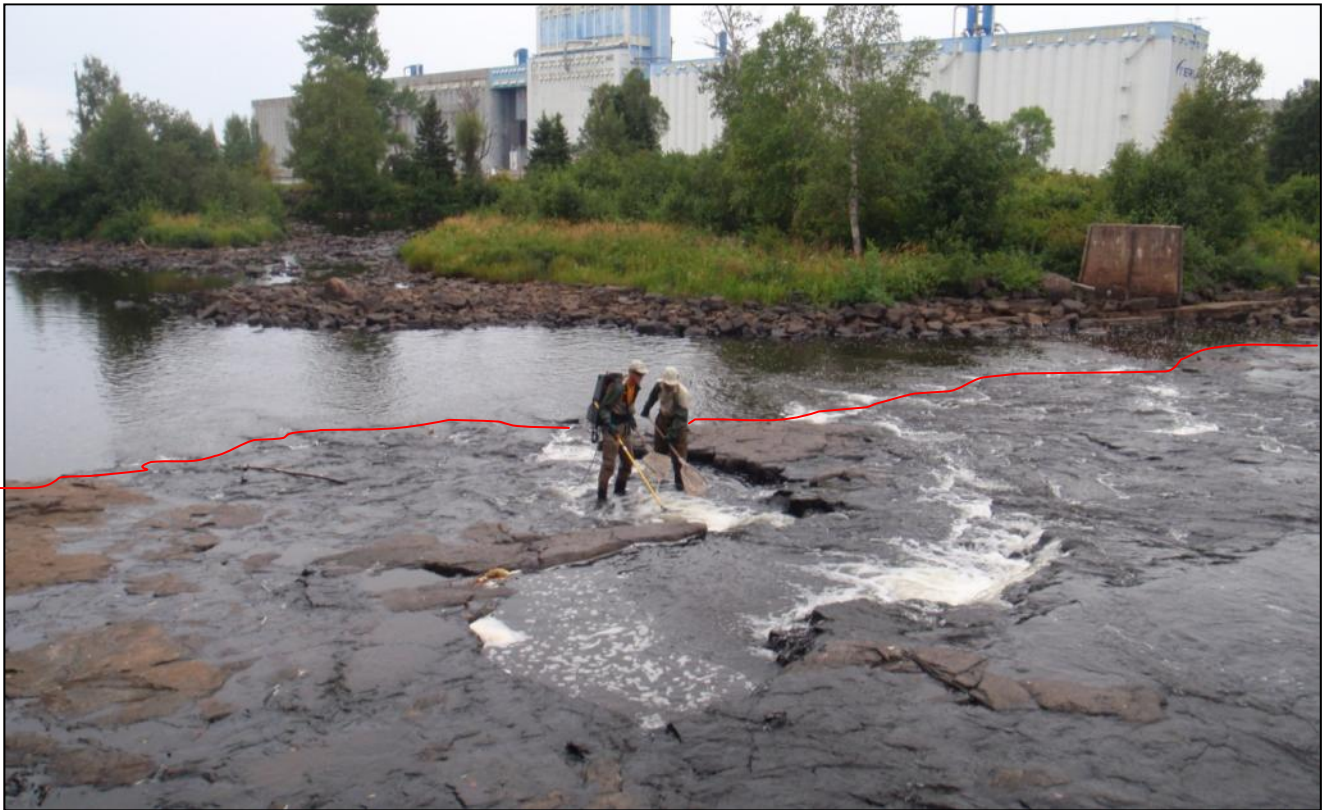
Figure 8. Bedrock pools at base of sheet above islands at mouth of the Current River. The red line marks the approximate upper limit of the effect of Lake Superior water levels.

Water levels at the mouth of the Current River are strongly influenced by Lake Superior water levels since there is very little drop in elevation from the base of the bedrock sheets above the islands (Figure 8). Most of the riverine habitat during sampling at the mouth showed little or no visible flow across much of the transects surveyed (Appendix 2). Maximum water depths on the survey transects ranged from 14 to 76 cm (Figure 9, Table 2), with deeper water towards the open lake. Substrates were predominately cobble along surveyed transects although there are pockets of gravel among the coarser material. The proportion of gravel, sands, and silts appears to increase in deeper water farther downstream deeper water (>1 m) that could not be effectively sampled. The average size of regularly sampled particles (centre of sample ring) did not vary significantly between the main, middle, and secondary channels, but the average size of the largest particles was greater in the main channel (364 mm vs. 302 mm in middle channel and 263 mm in secondary channel). Transect water depths were greater in the secondary channel. Not surprisingly, there was a higher proportion of substrate with a silty film in the secondary (west) channel rather than in the main channel where increased flow keeps silts suspended. Under low flows, this suggests that suitability of cobble substrates in the secondary channel for walleye, white sucker and other species might be reduced compared to the main channel, particularly under low flow conditions. However, high spring flows may reduce this potential effect.

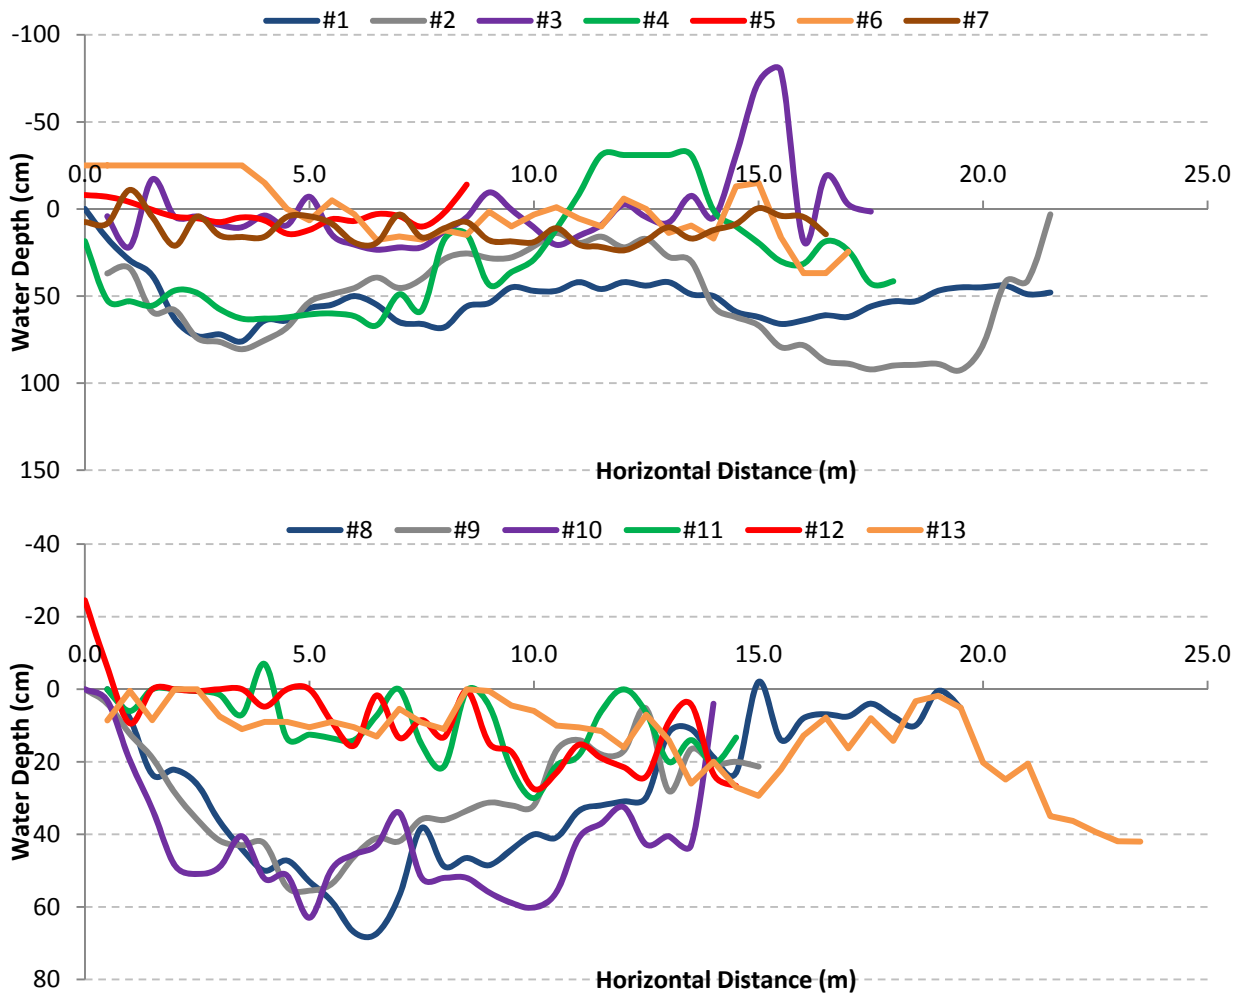
Figure 9. Cross-sectional profile of 13 substrate transects at the mouth of the Current River. See Appendix 2 for raw data and Figure 5 for location of transects.

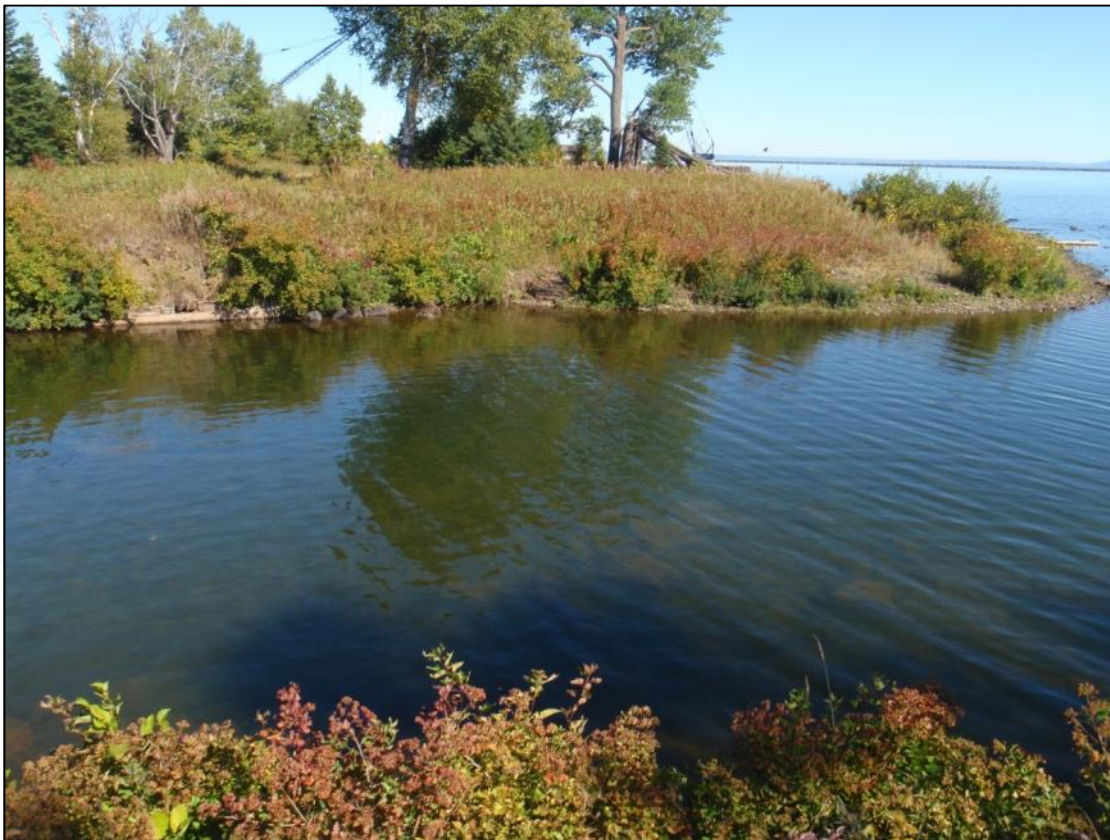
Figure 10. Secondary channel looking east on Sept 9, 20011.

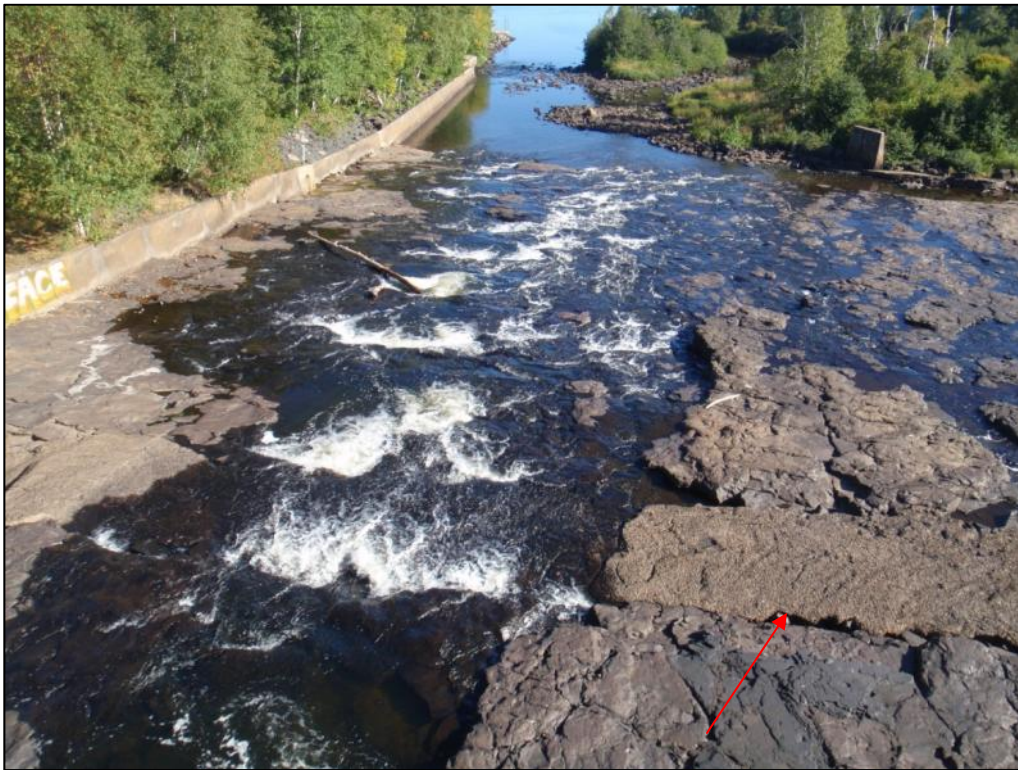
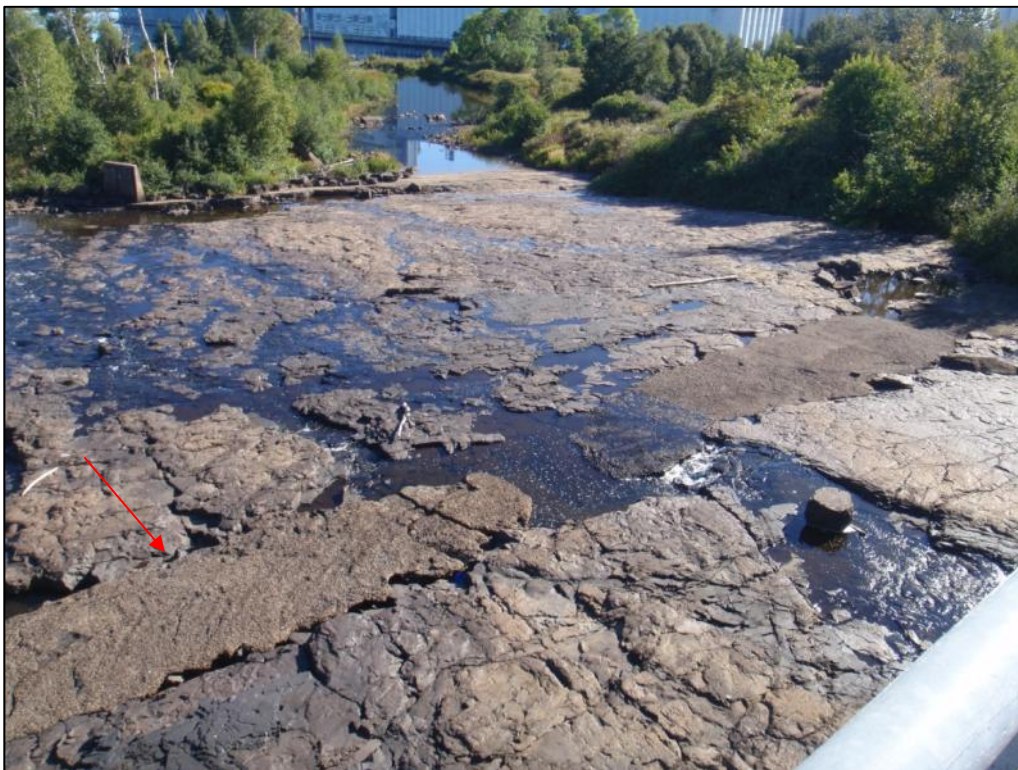
Figure 11. Current River below Shipyard Road, Sept. 9 looking at main (upper photo) and secondary channels (lower photo). Arrow denote band of concrete that cuts across channel.

Pool habitats represent approximately 7100 m² under low flow conditions, approximately half of which are predominately bedrock. A series of eight bedrock pools are located along the east side of the channel in the main flow (Figure 11). The pools are approximately 1.5 to 3 m in diameter and up to 1.5 m in depth. Based on drill holes, they were apparently blasted out, presumably to enhance upstream fish passage towards the fish ladder. A series of 7 or 8 similar-sized pool appears to have been blasted out the slaty bedrock in the 100 m approaching the fish ladder as well. Although pool habitats represent only about 35% of the wetted habitat at low flows, they provide significant fish habitat. In particular, the bedrock pools above the GS encompass approximately about 2000 m² or 8% of the total channel area above the GS but contained 477 fish of eight species (Table 4, Figure 20).

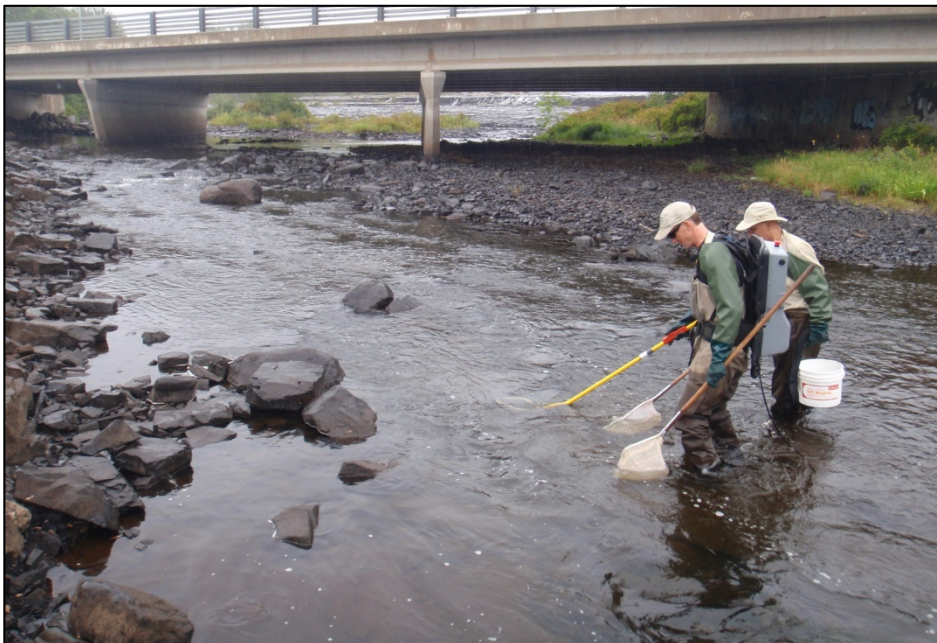
Figure 12. Cobble substrates below Cumberland Street, Sept 3, 2011.

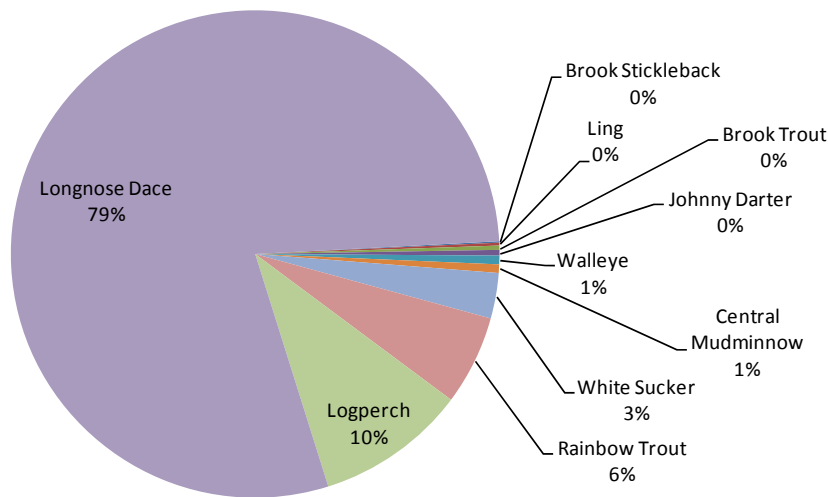
Figure 14. Proportion of fish species sampled in the Current River below Boulevard Lake by 2011 electrofishing (0% represents <1%).

A total of 1063 individuals of ten species of fish were sampled by electrofishing on August 31 and September 3 from the Current River below Boulevard Lake dam downstream to the islands at its mouth (Figure 14, Table 4). The fish community was dominated by species typical of lotic (flowing) environments in northwestern Ontario (Holm et al. 2009; Hartviksen and Momot 1987). Additional sampling at other times of the year and at the river mouth would likely yield other fish species; at least 15 species of fish have been recorded from the Current River (Nelson et al. 2007; Hartviksen and Momot 1987). Young of the year (YOY) smallmouth bass were observed in 2011 in shallow water near the islands at the mouth of the Current River but were not sampled during electrofishing.

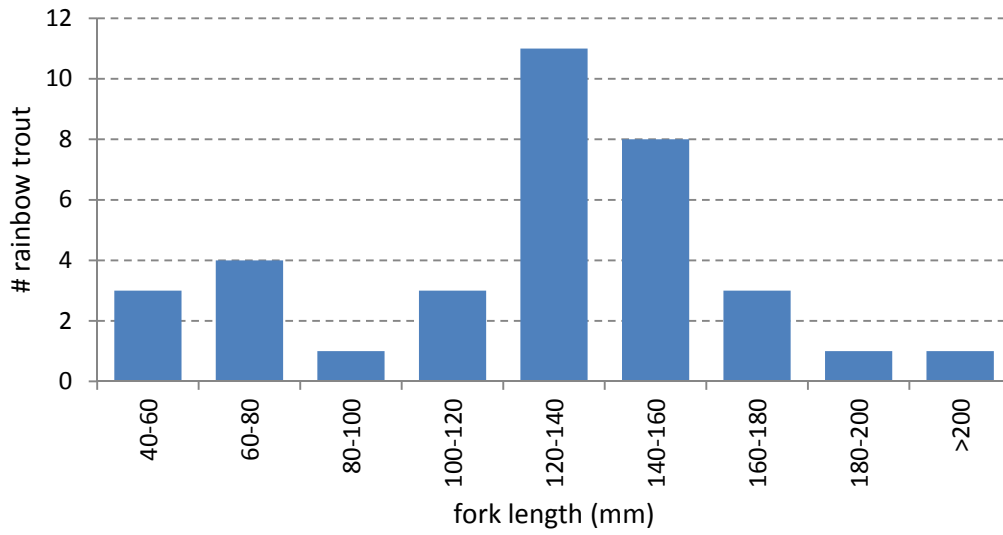
Figure 15. Size distribution of rainbow trout electrofished below Boulevard Lake dam and the mouth of the Current River in 2011.

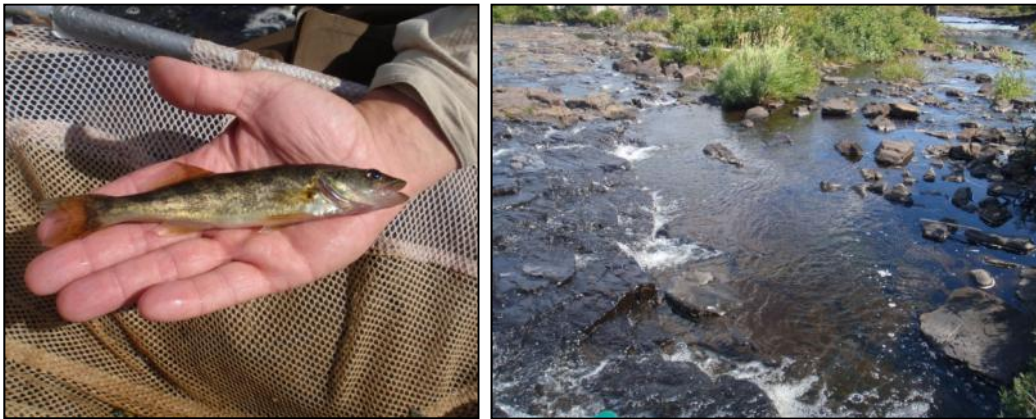
Figure 18. YOY walleye and pool where it was electrofished.

One adult walleye (*Sander vitreus*) and 5 YOY were sampled during 2011 electrofishing. YOY walleye were caught in several bedrock pools above and below Cumberland Street (Figure 18). The adult was approximately 350 mm in size (it escaped measurement) and was found in the large pool at the base of the largest step midway between the dam and Cumberland Street (Figure 19). This pool was approximately 10 m x 30 m with a maximum depth of 1.8 m with a bedrock substrate. A YOY walleye was caught in this pool as well. The ability of walleye to access this reach of river during the spawning period is unknown and may vary from year to year. The adult and all YOY walleye may represent downstream drift from walleye populations in the Current River above Boulevard Lake Dam rather than fish that originated in Lake Superior. A total of 32 YOY white suckers (*Catostomus commersonii*) were also sampled, and ranged in size from 35 to 162 mm TL (mean 75 ± 20 mm). They have generally similar spawning requirements as walleye, and may have originated upstream of Boulevard Lake. The two ling (*Lota lota*) sampled were also in small bedrock pools, and could be downstream migrants (“drop-downs”) or could be resident.

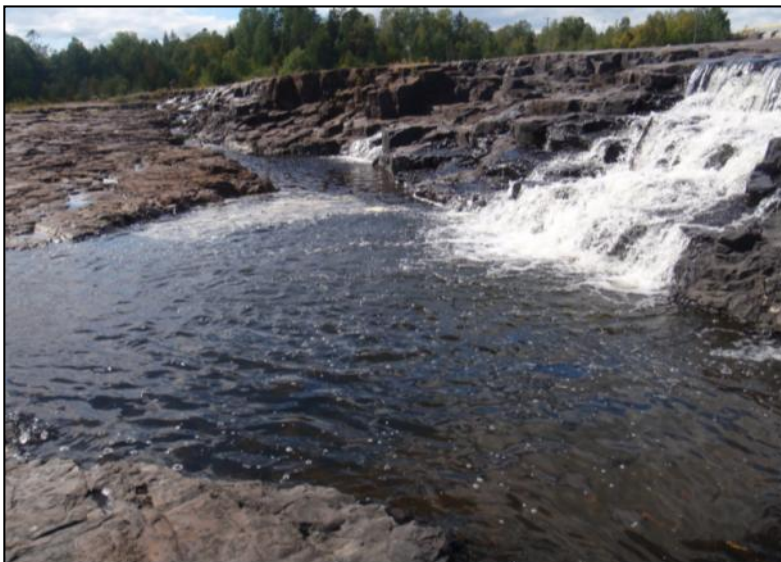
Figure 19. Large pool in Reach 15 where adult walleye was electrofished.

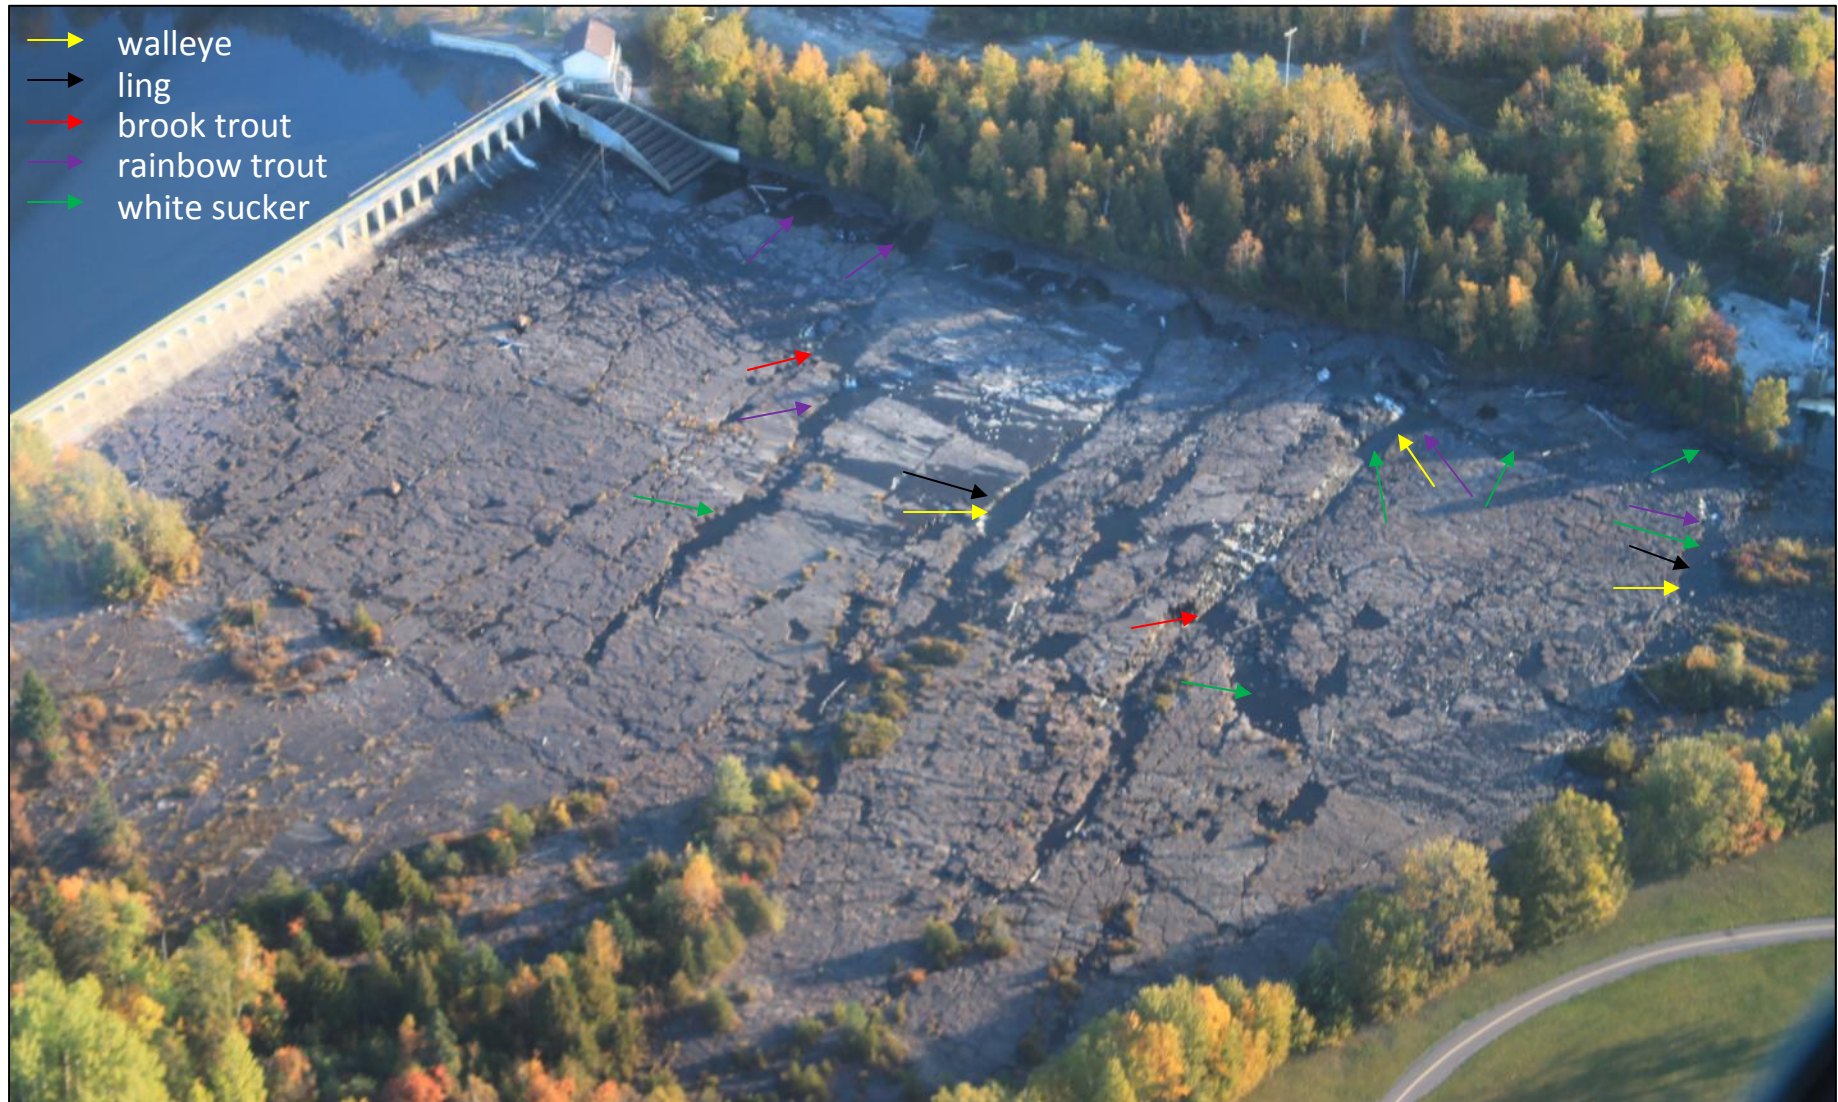
Figure 20. Current River between Boulevard Lake dam on October 3, 2011. Arrows denote locations where selected fish species were caught.

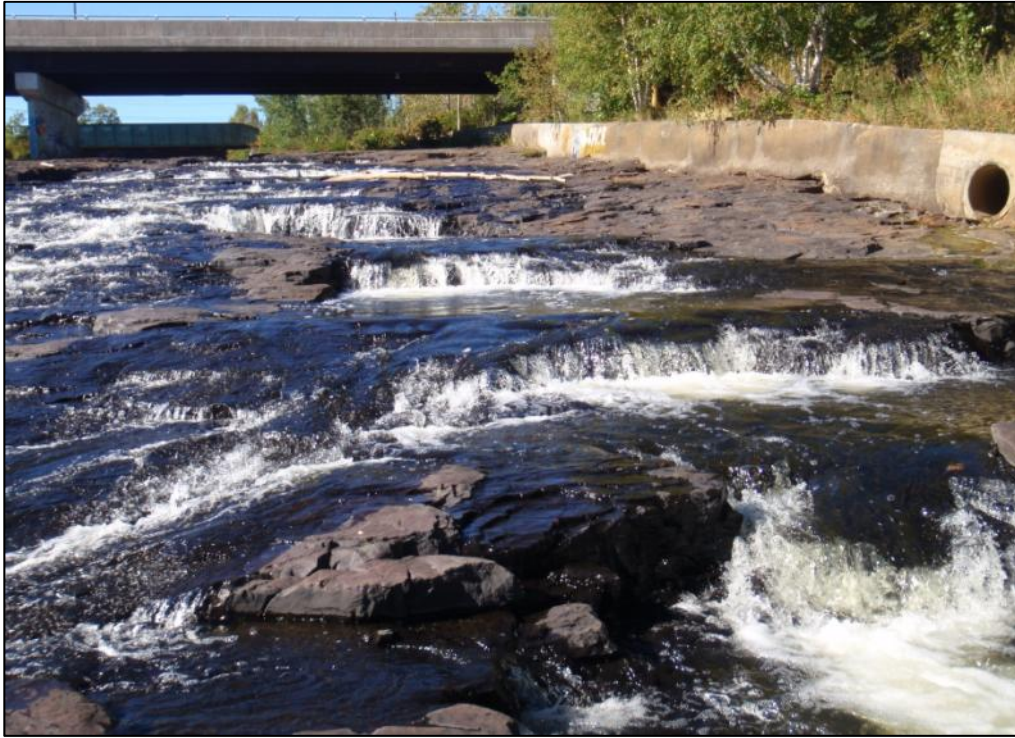
Reach #1 below Shipyard Road with bedrock pools and steps, Sept. 9.

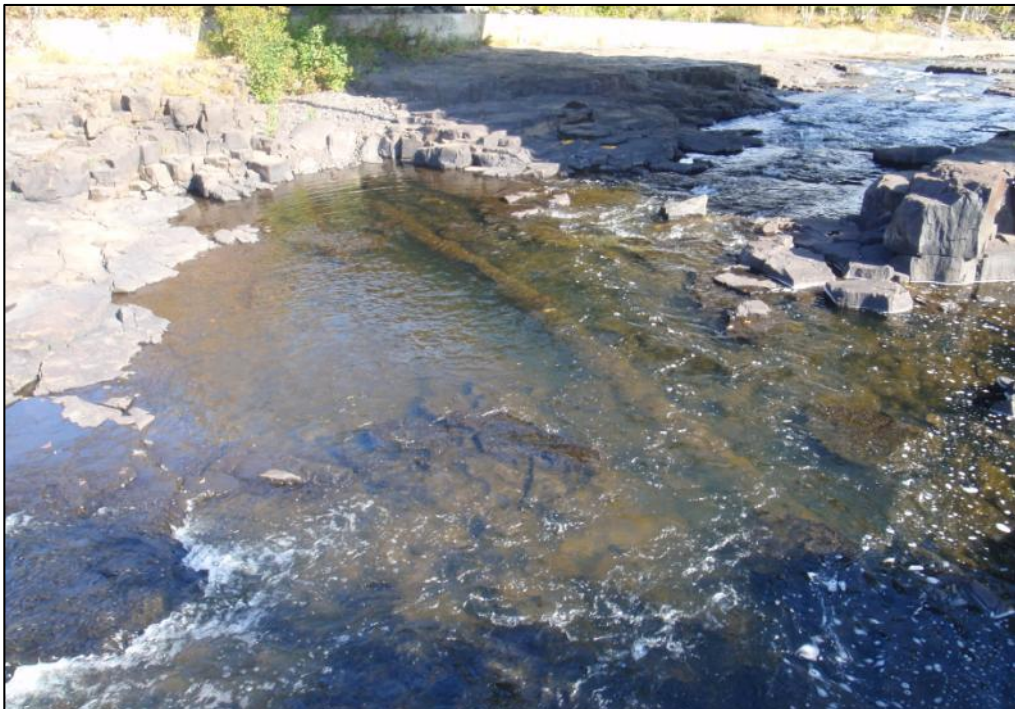
Reach #2 below Shipyard Road bridge with bedrock pools and steps, Sept. 27.

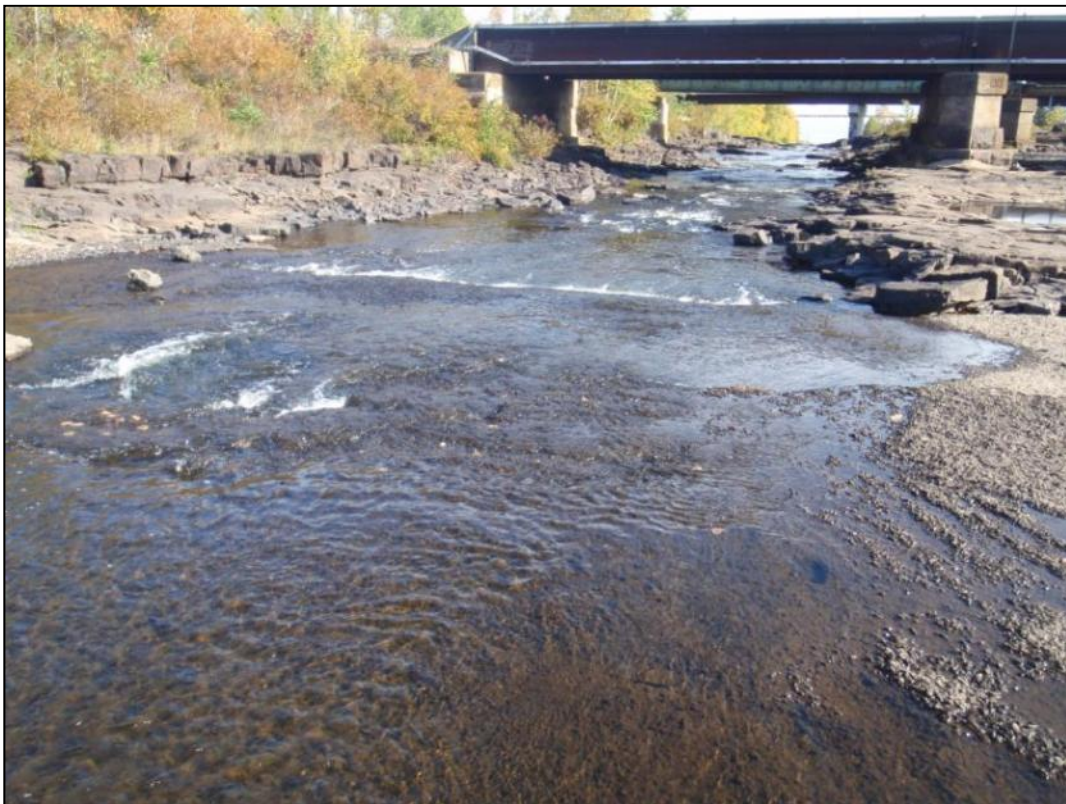
Concrete sheet in Reach #6 above 2nd railway bridge looking downstream, Sept 27.
